Elinor Lake South Dam 2020 Dam Safety Review Report

For Regional District of Okanagan-Similkameen

Elinor Lake South Dam - 2020 Dam Safety Review Report

H362819-00000-228-230-0004

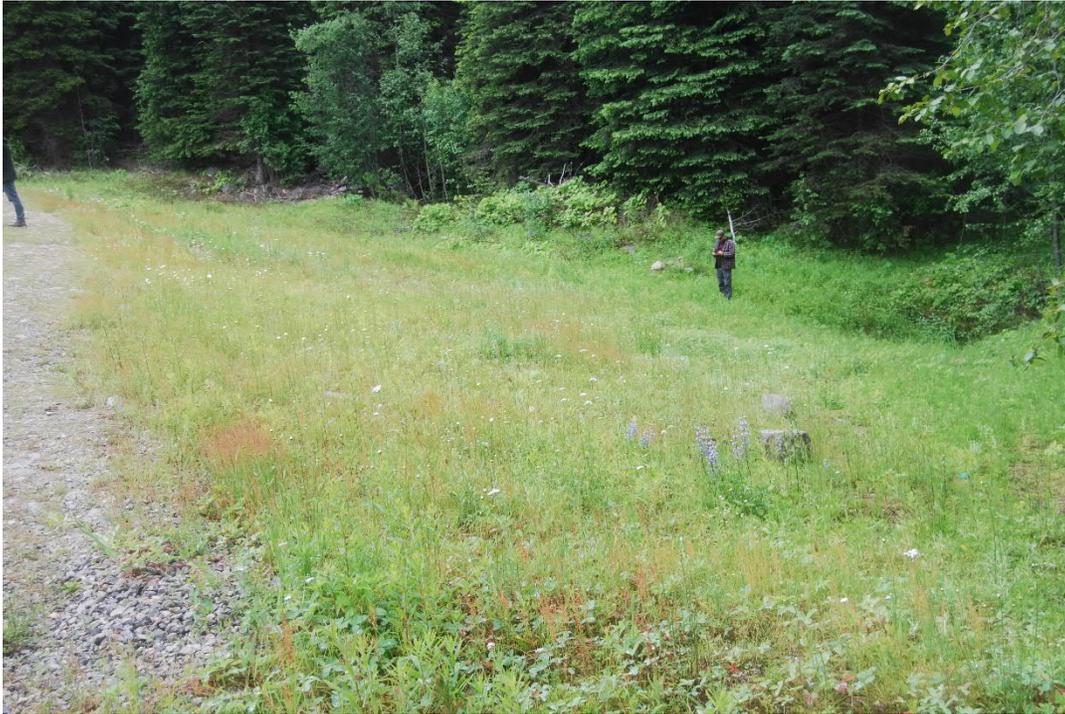
Photo A5: Elinor Lake South Dam Downstream Slope and Outlet Works

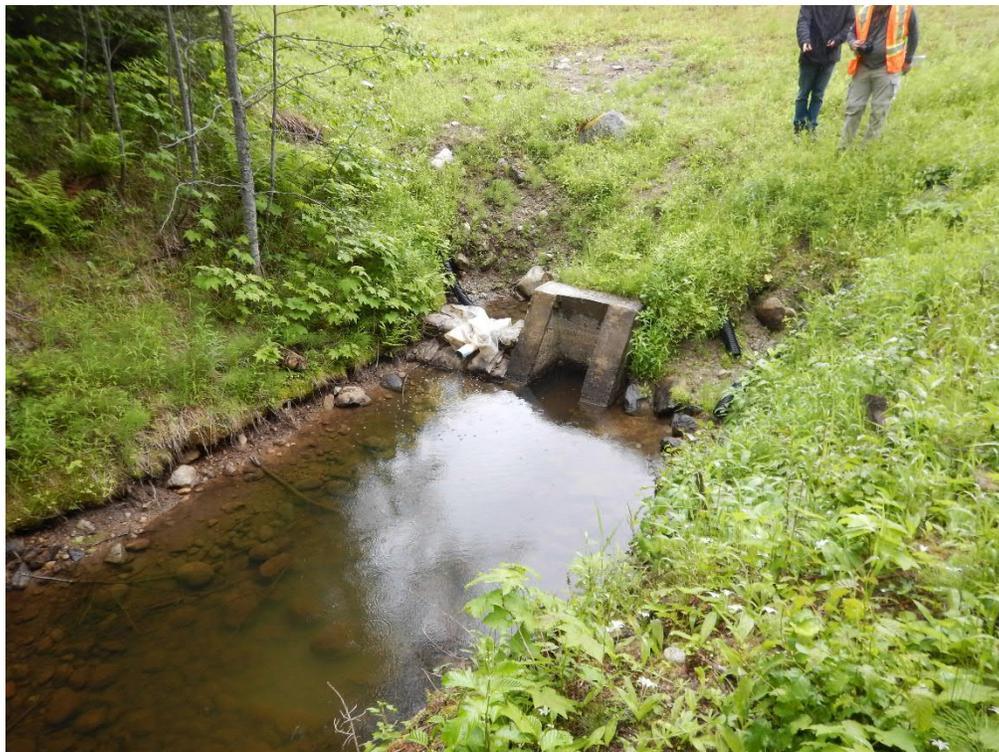
ES-4	Evidence of seepage was observed at the downstream toe. However, heavy vegetation limited access to the area where seepage was observed.	2010 DSR FLNRO, 2019 2020 DSR	NCs	Outstanding	Extend limits of vegetation clearing downstream of the dam to allow for inspection of the toe and regular seepage observations.	Medium
ES-5	A detailed geotechnical assessment could not be completed due to the absence of construction documentation and site-specific geotechnical data. The dam is potentially susceptible to failure modes including slope instability, piping, and liquefaction.	2010 DSR 2020 DSR	NCi	Outstanding	Geotechnical assessments should be undertaken upon completion of the recommended geotechnical investigation. These should evaluate risks of common failure modes including seismic and normal slope stability, piping, and liquefaction. It is expected that the results of these assessments may lead to a recommendation for construction of a toe berm or similar improvements to limit seepage and increase the stability of the dam at the downstream toe. In addition, internal stability assessment of dam core and filter compatibility assessment should be conducted.	High

Photo A6: Elinor Lake South Dam Outlet Works, Tailrace Channel, Seepage on Right of Structure

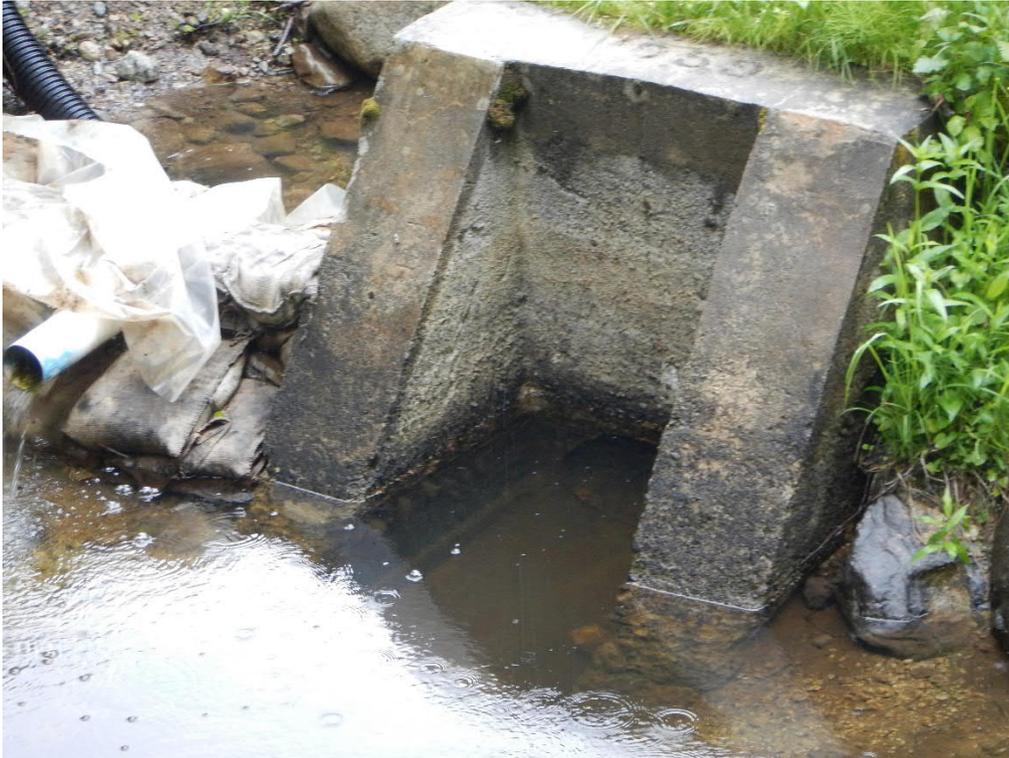
Photo A7: Elinor Lake South Dam, Outlet Structure

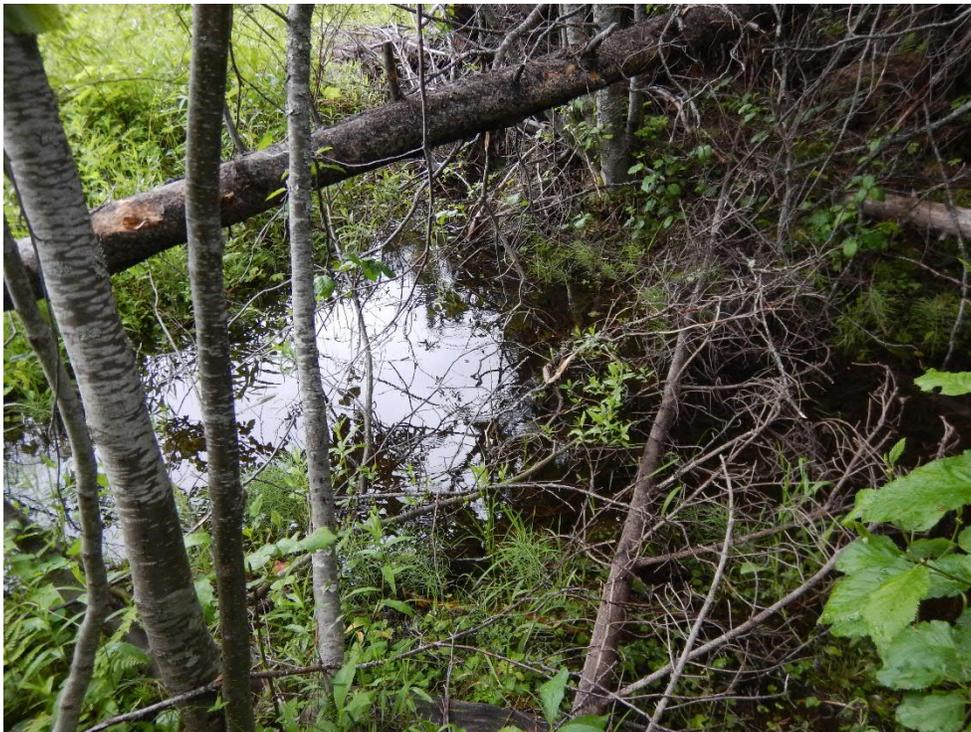
Photo A8: Elinor Lake South Dam Downstream Pond, left of Outlet Structure

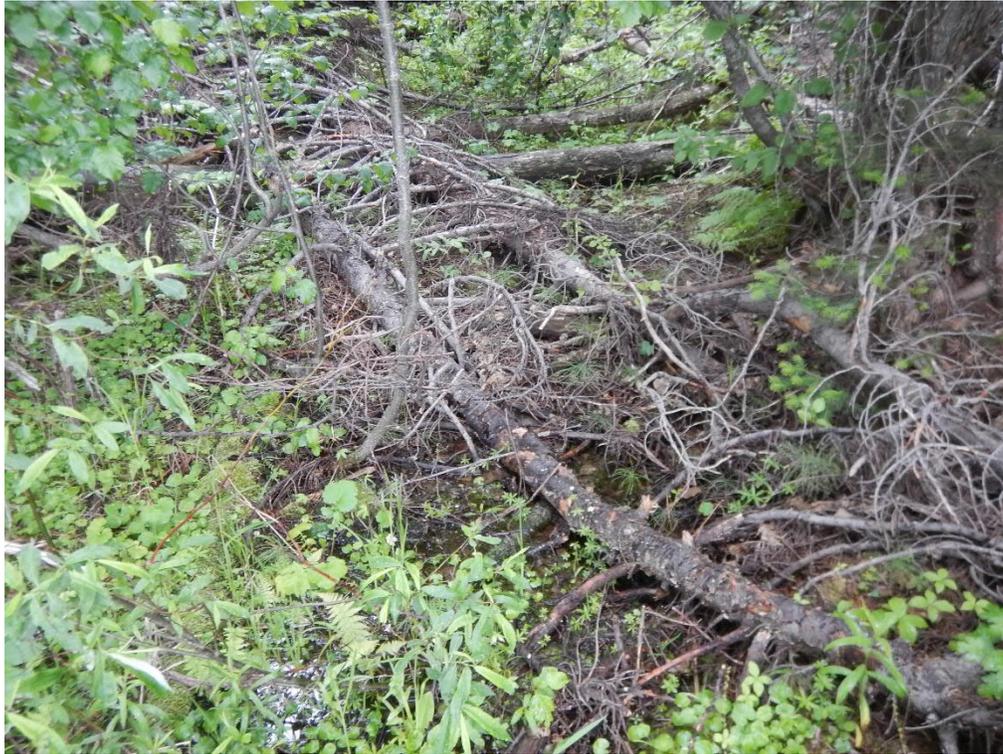
Photo A9: Elinor Lake South Dam, Dead Trees Stored at the Dam Toe

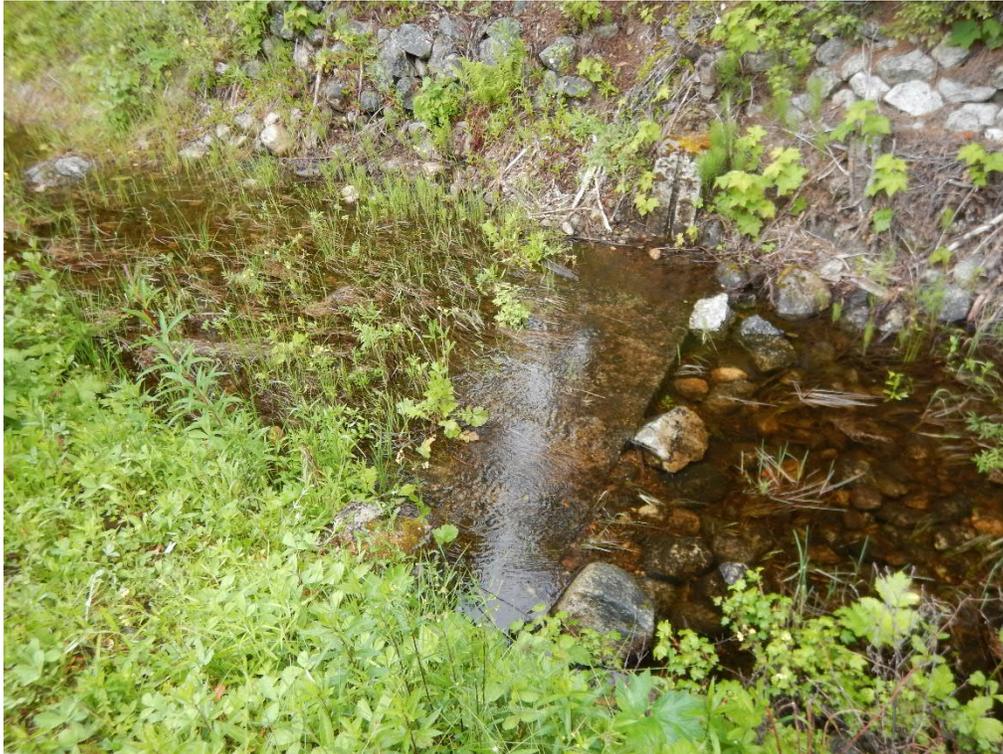
Photo A11: Elinor Lake South Dam, Spillway Seal Structure

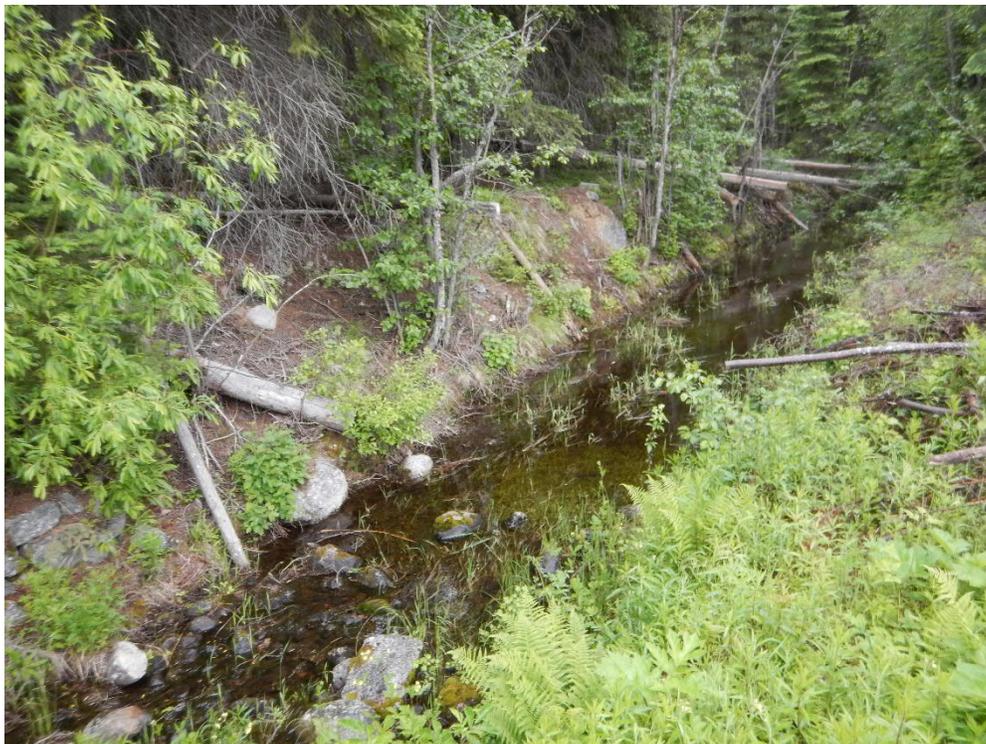
Photo A12: Elinor Lake South Dam, Spillway Channel, Downstream Area

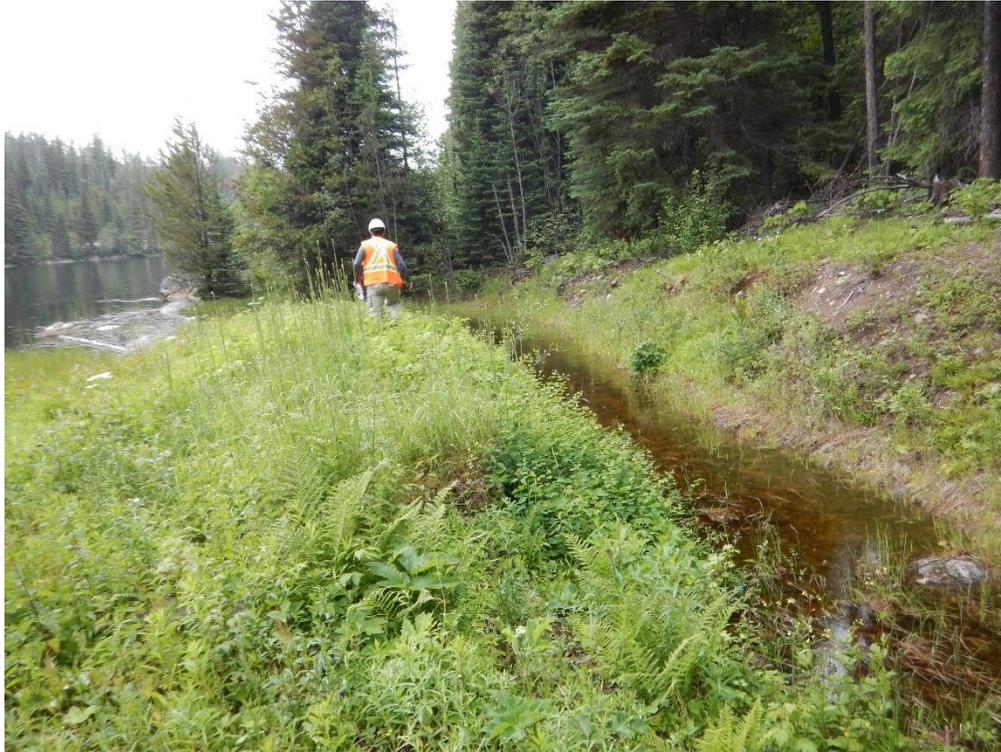
Photo A13: Elinor Lake South Dam, Spillway Channel, Upstream Area
