FIRESMART COMMUNITY ASSESSMENT REPORT

REGIONAL DISTRICT OF OKANAGAN SIMILKAMEEN &

THE MISSEZULA LAKE FIRESMART BOARD

DECEMBER 2018

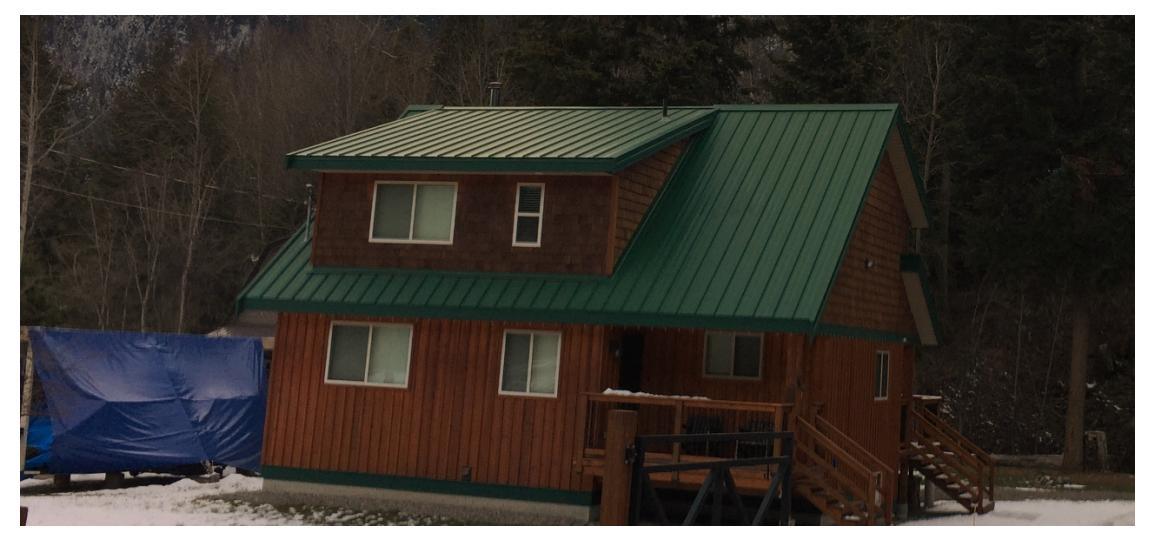
Figure 7 Roofs with a ULC rating, such as this metal roof, provide a high degree of fire resistance able to withstand ember ignition.

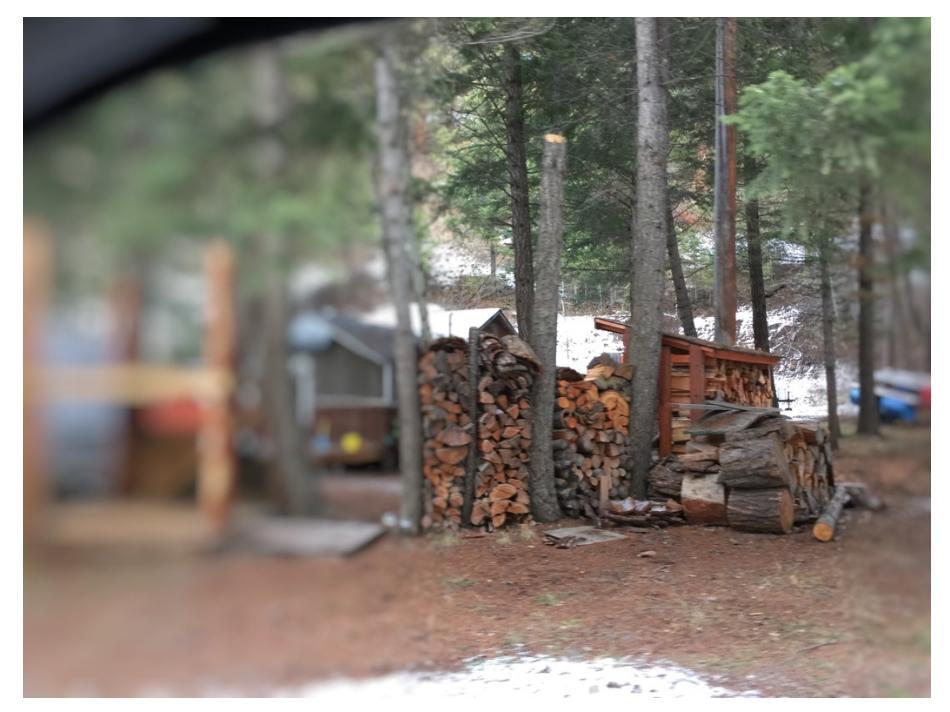
Figure 8 The presence of nearby vegetation and combustibles that can ignite with relative ease and burn with highintensity can present a fuel hazard to a building's exterior.

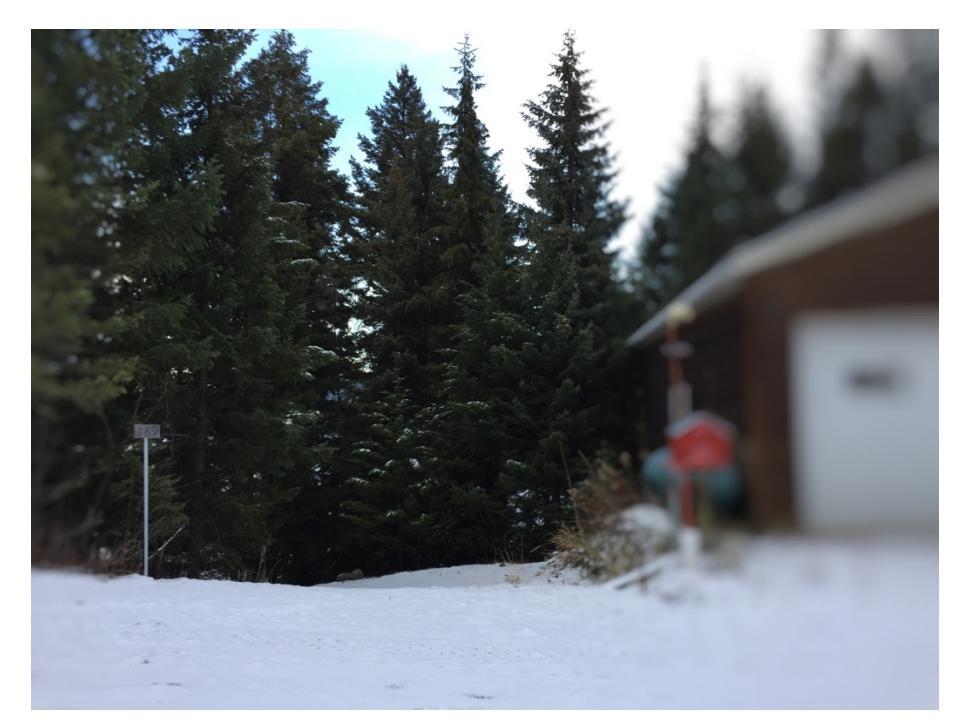
At Missezula, some homes have lawns and others have natural grasses. The majority of ladder fuels in PZ-1 are attributed to juvenile conifers and unpruned Douglas-fir (Fd). The overstory in the PZ-1 its predominantly Douglas-fir (Fd).

Figure 9 The conifer trees in this photograph have ladder fuels extending down to the ground. This is an example of Zone 1 conifers presenting a hazard to the adjacent structure.

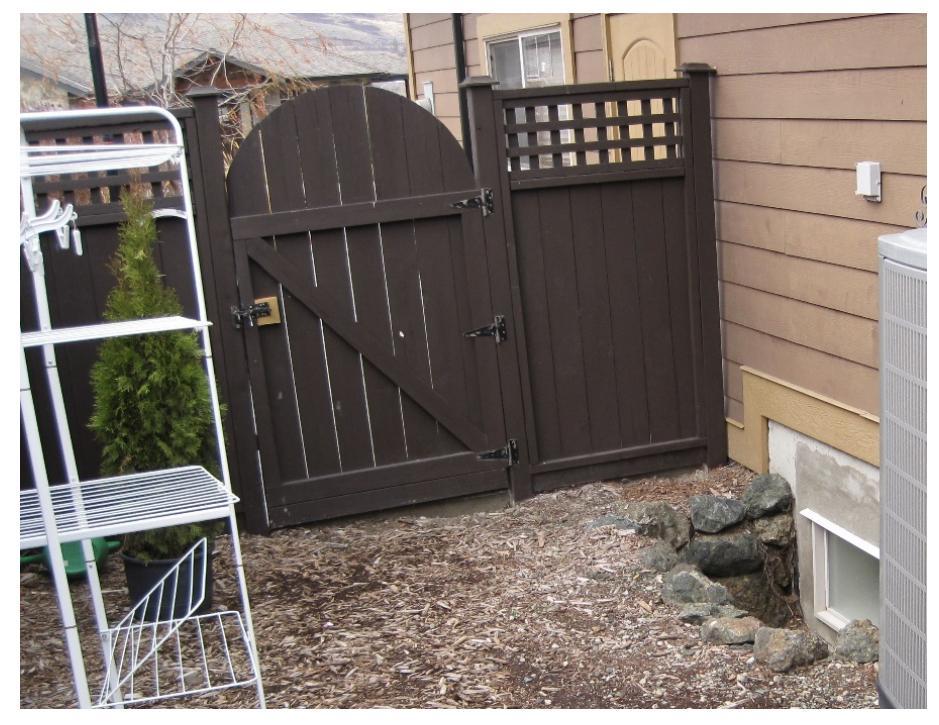
Figure 10 This wood fence bisects a bark mulch bed and connects to the house. Embers could ignite the bark mulch, leading to the fence catching on fire and posing a threat to the attached house. Note: this photo is not from Missezula.

As well, a wood fence that backs onto natural grasses could ignite from a low-intensity surface fire moving through the grass. In either case, the length of the fence could burn, including the portion where the fence attaches to the house, potentially leading to ignition of the structure. One strategy that can help to maintain the privacy of a wood fence while also lowering the chance of a connected fence from igniting the house, is to install a metal gate at or near the fence-house junction.

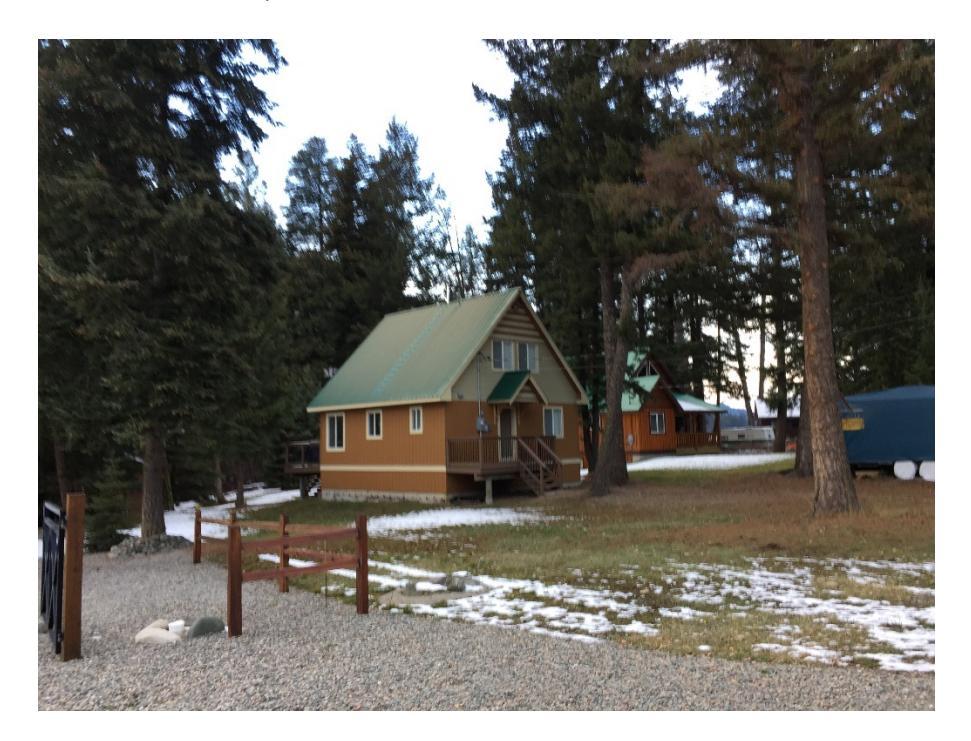
Figure 11 Steep-pitched metal roofs are common at Missezula Lake. This property is also a good example of a fuelmanaged Zone 1 with occasional well-pruned and spaced large diameter conifers.

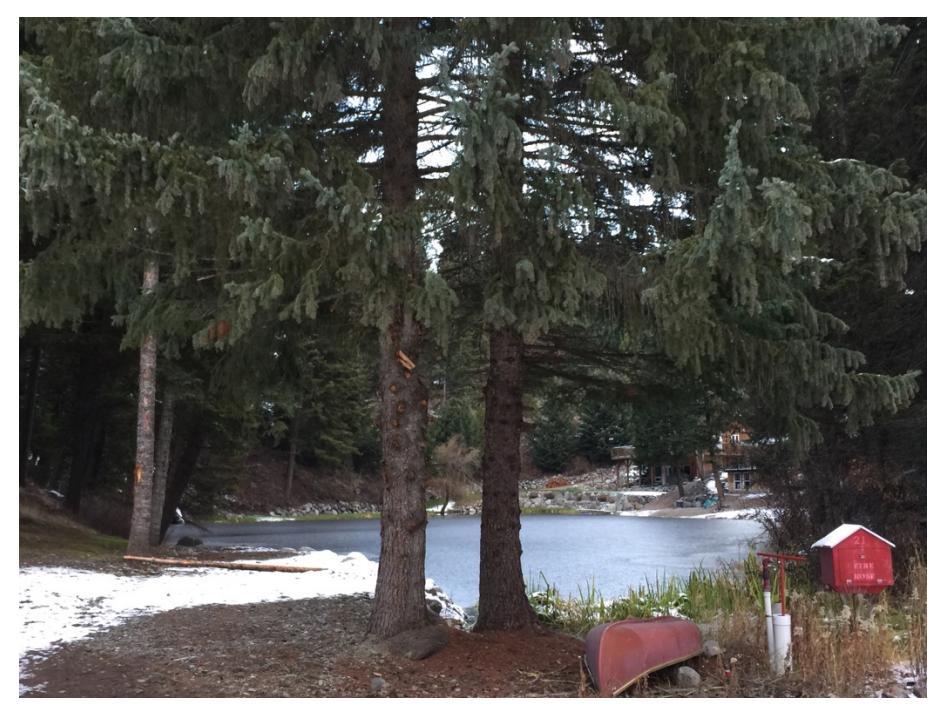
Figure 12 An example of the removal and/or thinning of conifers in Zones 1 and 2. Note the standpipe and hose box in the lower right of the photo.

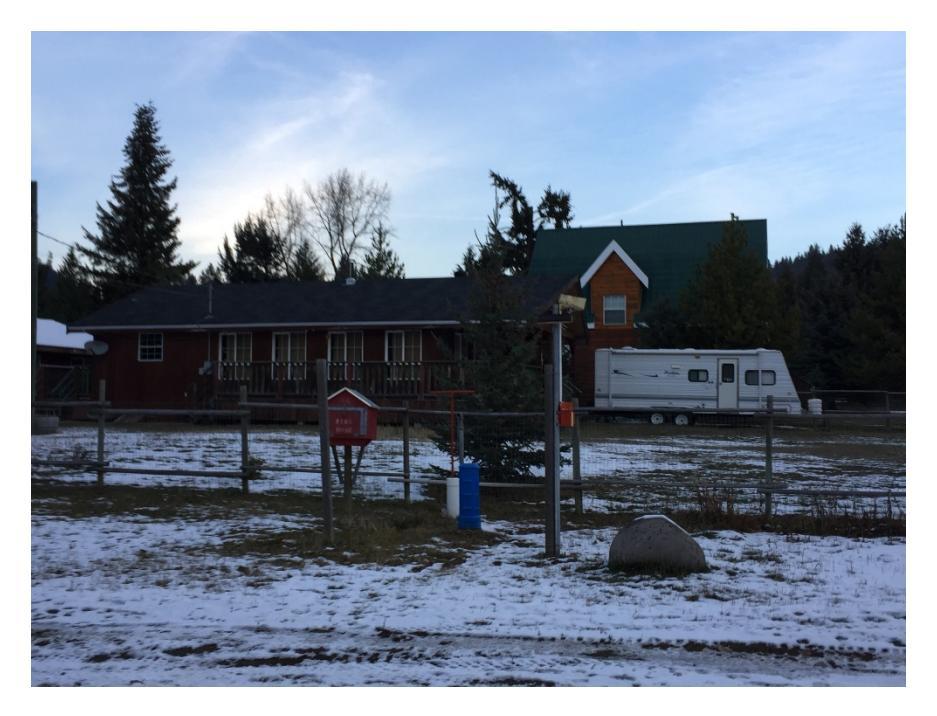
Figure 13 One of a number of standpipes equipped with a hose box and warning alarm located throughout the Missezula Lake community.

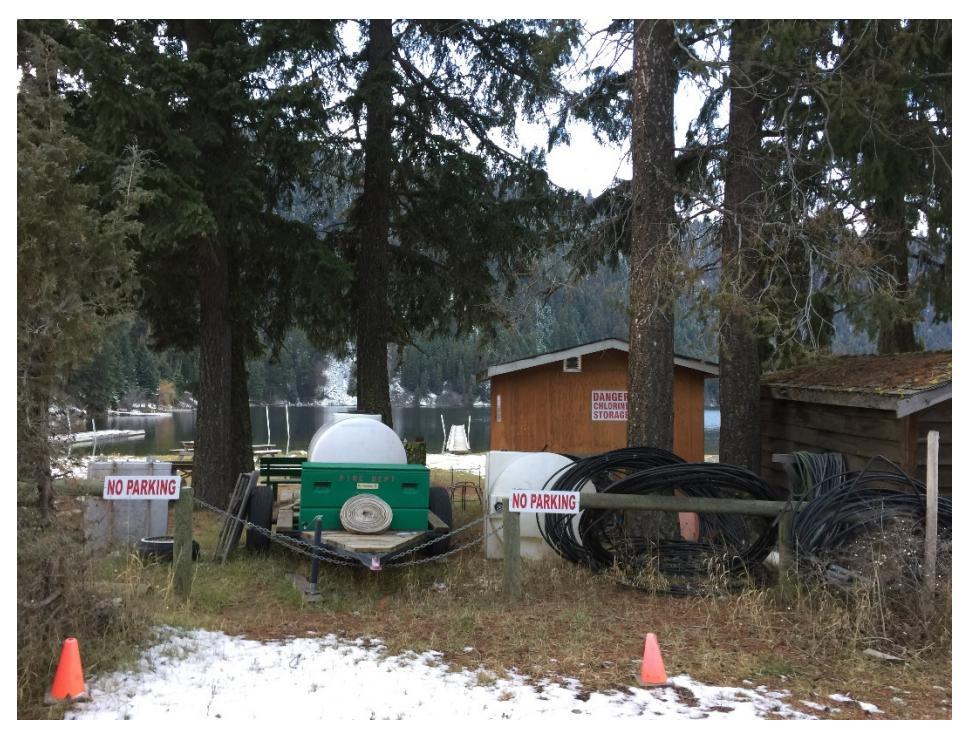
Figure 14 Missezula Lake owners have several portable water tanks and various firefighting equipment staged at the water treatment plant.
