# Campbell Mountain Landfill

## 2022 Annual Report

### Operational Certificate: I5274

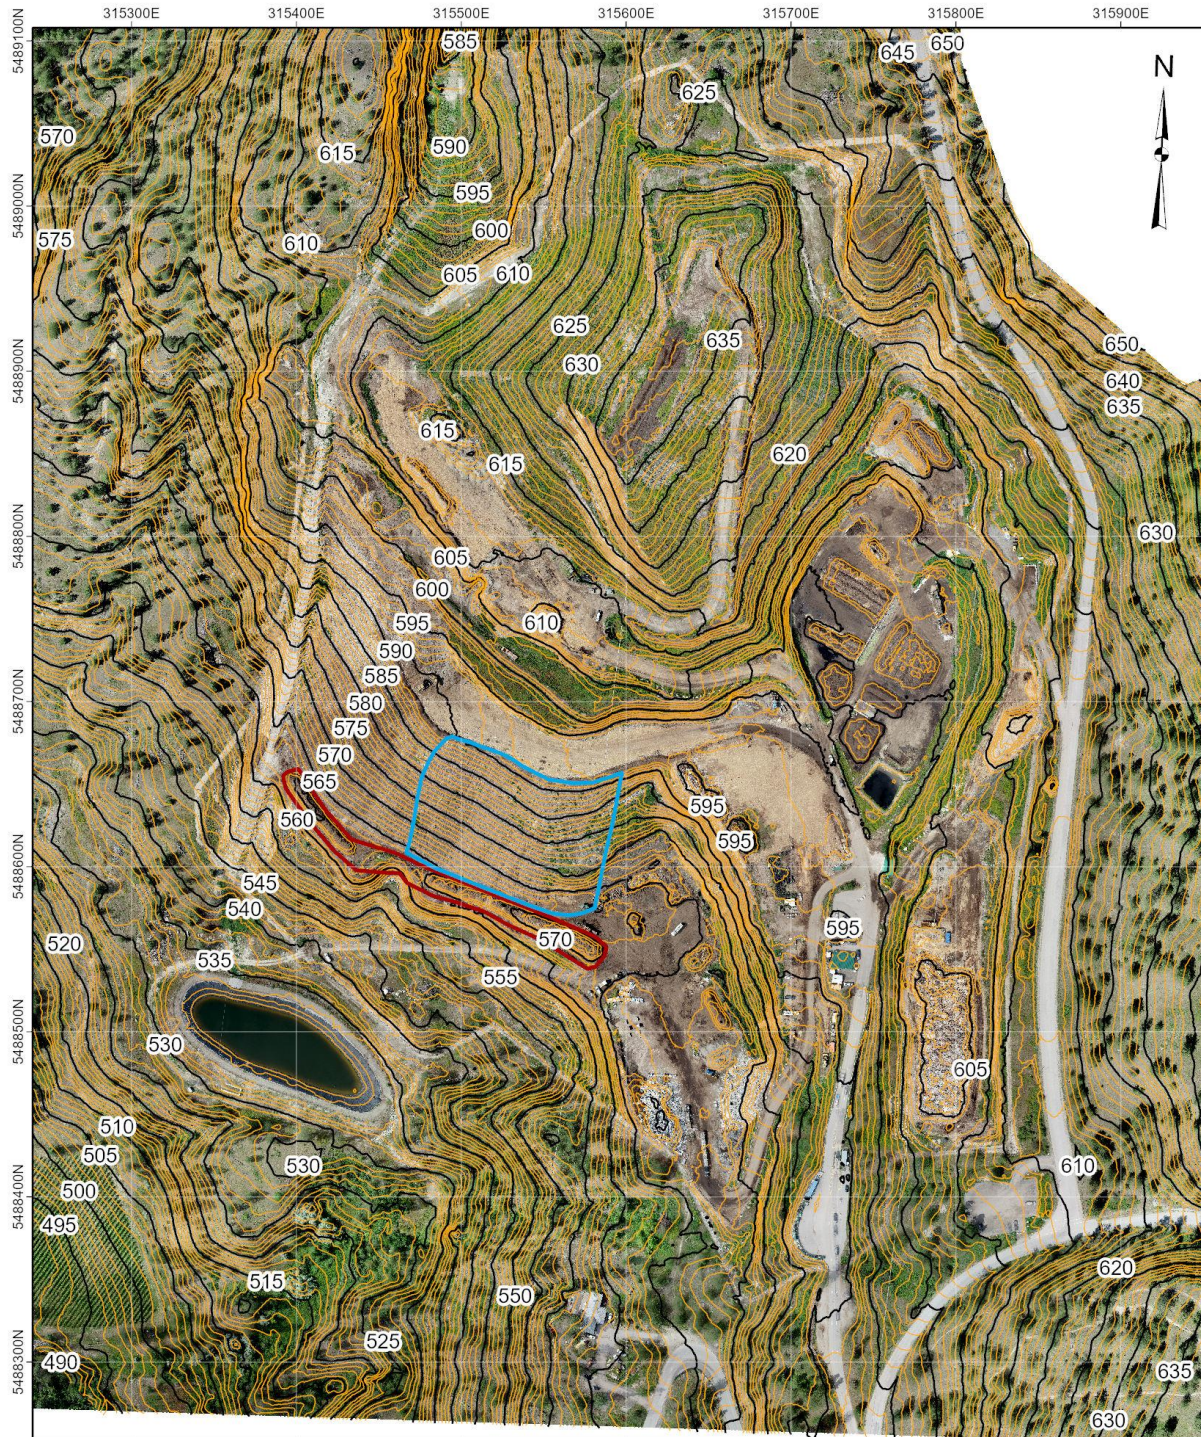
Figure I(b): March 2023 Topographic Map of Campbell Mountain Landfill

5m Contour	Aerial photo : 21/06/2022
	1m Contour	
	Active Face	NAD 1983
	Soil Stockpiles and Borrow Areas	UTM Zone 11N
		1:3,500

CAMPBELL MOUNTAIN LANDFILL  
**TOPOGRAPHIC MAP**  
MARCH 2023
