Environmental Assessment for Proposed Strata Subdivision at 1750 Highway 3, Regional District of Okanagan- Similkameen

Dated: March 19, 2021

Ecora File No.: 180379

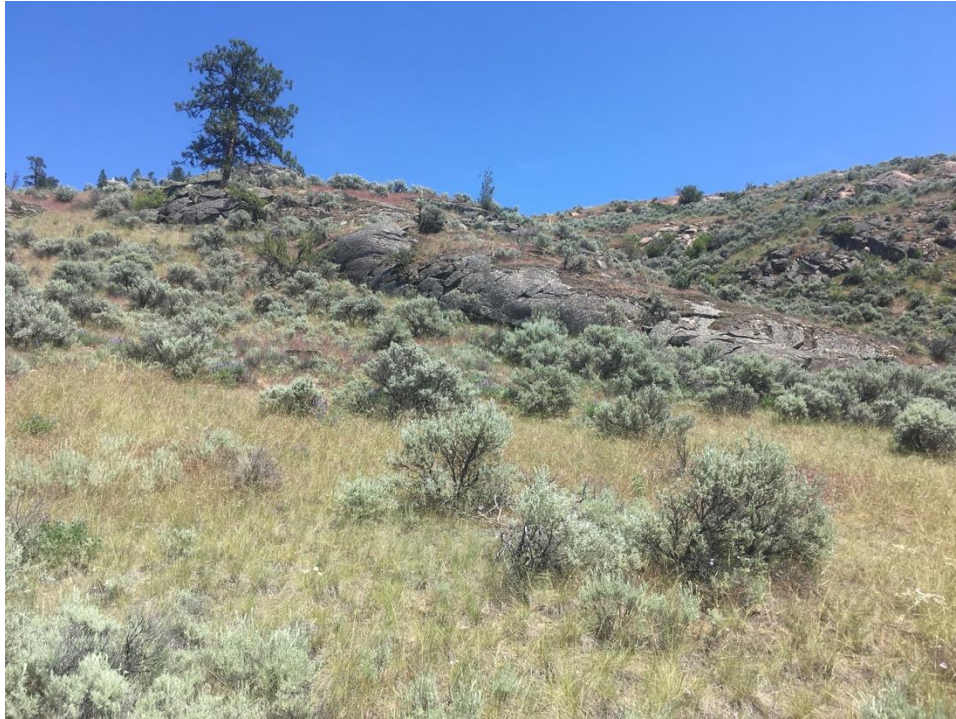
Photo 3.1 View of the typical sagebrush steppe habitats throughout the Property and within proposed future conservation area within SL 6 (June 3, 2020)

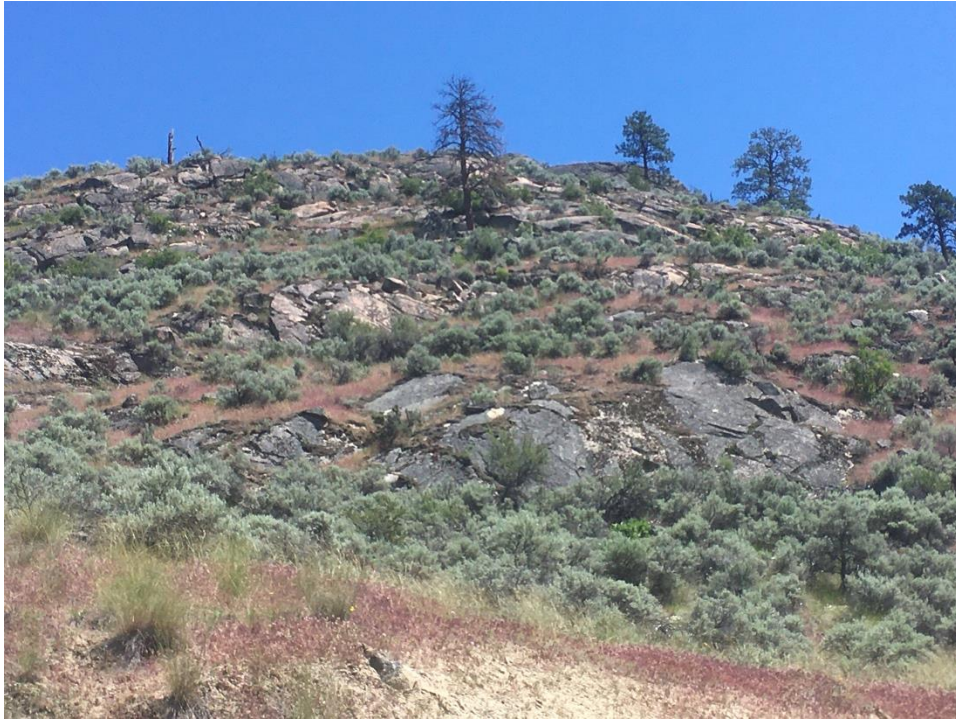
Photo 3.2 View of the patches of rock outcrop features identified as ESA 2 located throughout the upper portion of the Property and within proposed future conservation area within SL 6 (June 3, 2020)

Rocky outcrops and areas of exposed silty soils are present in patches throughout the Property, occurring in higher abundance in Polygon 3, with some outcrops present in Polygon 1, and not substantially present in Polygons 2 or 4. These areas provide habitat for unique plant species not occurring elsewhere in the Property including selaginella (*Selaginella spp.*), haircap mosses (*Polystichum spp.*), bitterroot (*Lewisia rediviva*), and lichens. Ponderosa pine, grasses such as bluebunch wheatgrass, fescues, and cheatgrass, and cacti also occur within these sparsely vegetated areas within Polygon 3, and sparse grass patches on outcrops in Polygon 1.

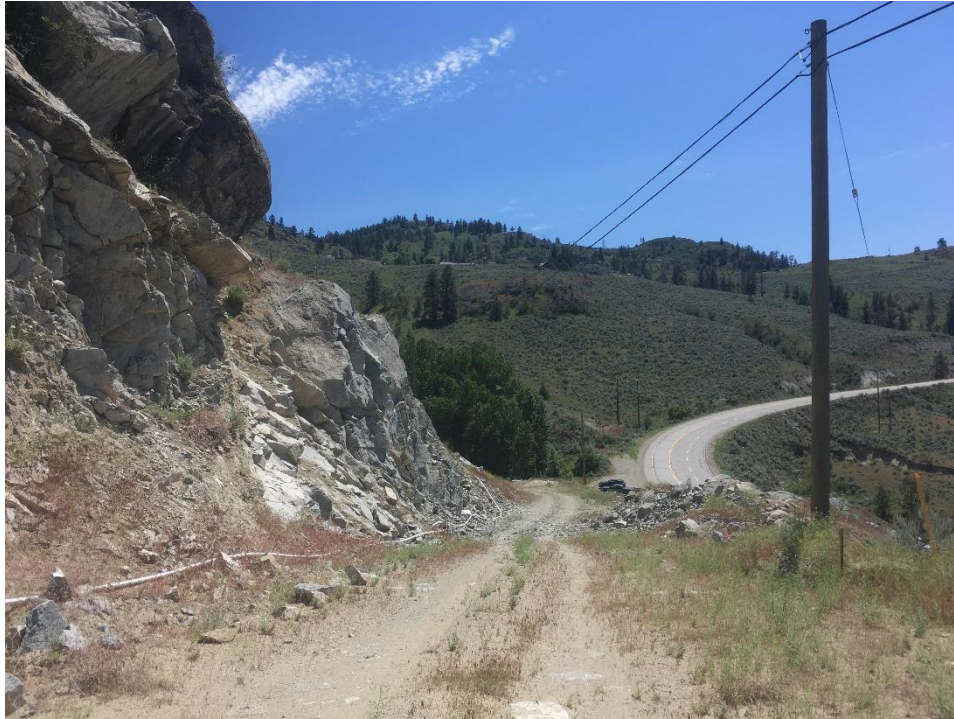
Photo 3.3 View of the driveway looking southeast towards Highway 3 (June 3, 2020)

Areas disturbed by human activity generally occur as graded or cleared areas such as the driveway, Lot 5 building pad and spoil pile (Polygon 2), as well as general degradation observed throughout Polygon 4. The areas within Polygon 2 were impacted by the excavation and blasting approved under the ESDP, with construction still underway at the time of writing. There is evidence of encroachment of non-native and invasive species within and along the fringes of disturbance, such as along the edges of Polygon 2 and in Polygon 4 due to the influence of the Highway, including knapweed (*Centaurea spp.*), great mullein, cheatgrass, and Russian thistle (*Salsola kali*).

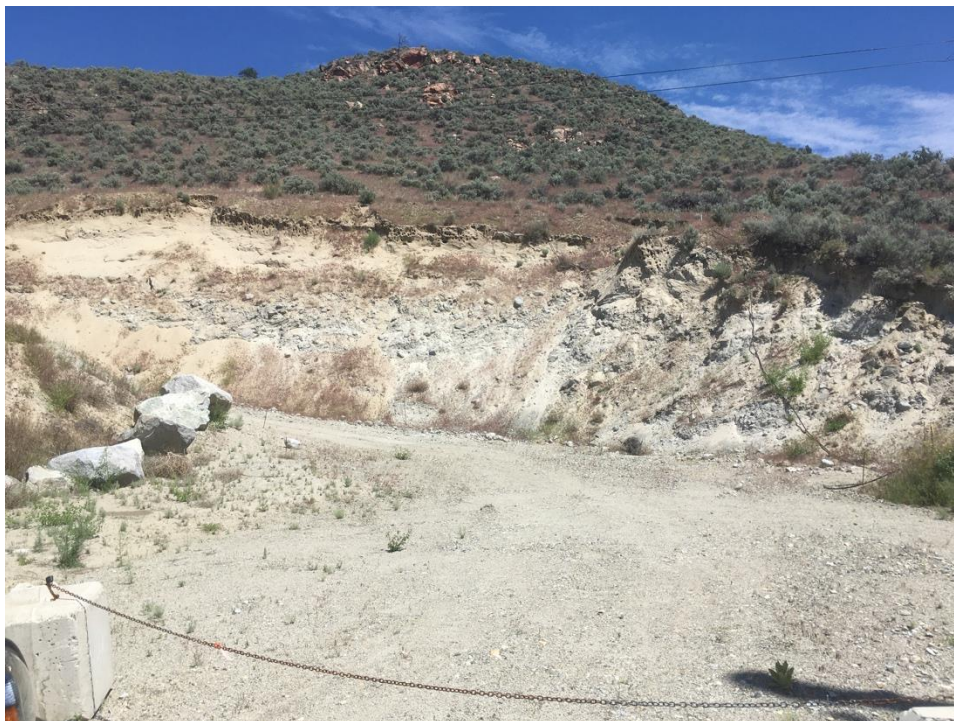
Photo 3.4 View of the site entrance from the eastern edge of Highway 3. Note the presence of cavities in the exposed cut bank which are associated with a colony of bank swallows (June 3, 2020)

Cut banks created during initial works on the driveway have created opportunities for mammals to dig burrows and bank swallows to nest. A bank swallow colony was observed to have formed near a temporary cut bank near the start of the driveway that was created during construction (Figures 4.0, 7.0) during the 2020 site visits and has been noted by RDOS and the Canadian Wildlife Service (CWS) and the importance of retaining the habitat feature has been conveyed to the Proponent and the contractors completing the work. In order to construct the driveway to specifications outlined by the geotechnical engineer, the slope the swallow colony was established on needed to be graded back further. Ecora consulted with CWS and RDOS on the management of the swallow colony, and it was determined that a replacement bank following a no net loss principle would be an acceptable means to allow the road to be safely finished. Following the construction of erosion protection works, Ecora attended the site on March 17, 2021 to oversee the creation of a replacement colony, following available Best Management Practices from Environment Canada, and the Ontario Ministry of Natural Resources on the creation of bank swallow habitat (ECCC 2020; OMNRF 2017). As the work was undertaken as part of the existing ESDP, a detailed summary of the restoration works have provided in a separate Environmental Monitoring report.

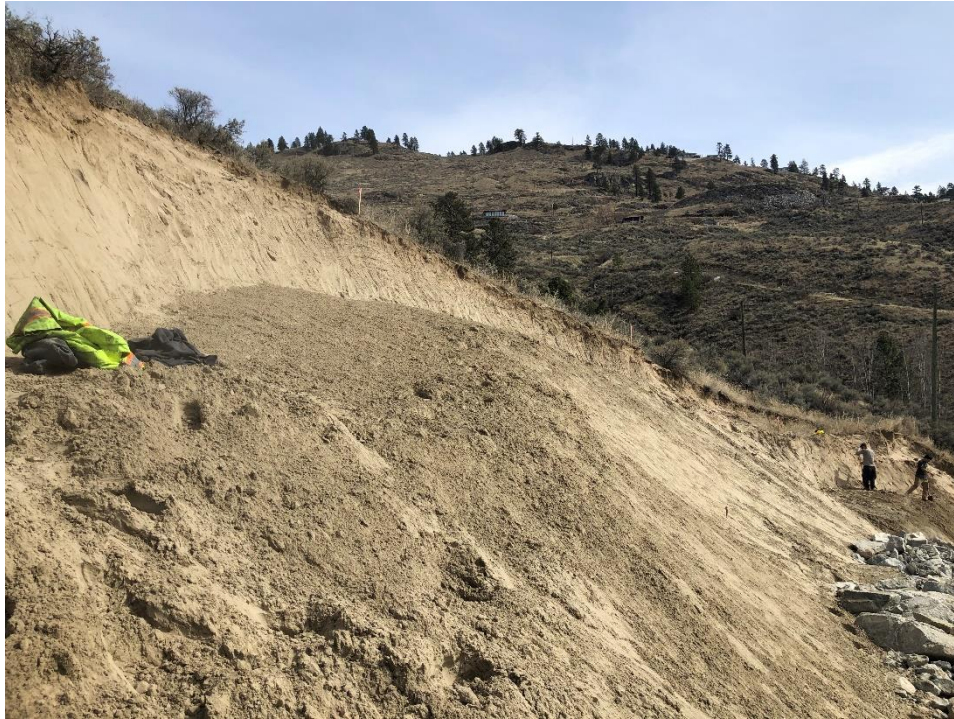
Photo 3.5 View of the enhanced swallow habitat at the same location as Photo 3.4, moved higher up the slope (March 17, 2021)
