Elinor Lake South Dam 2020 Dam Safety Review Report

For Regional District of Okanagan-Similkameen

Elinor Lake South Dam - 2020 Dam Safety Review Report

H362819-00000-228-230-0004

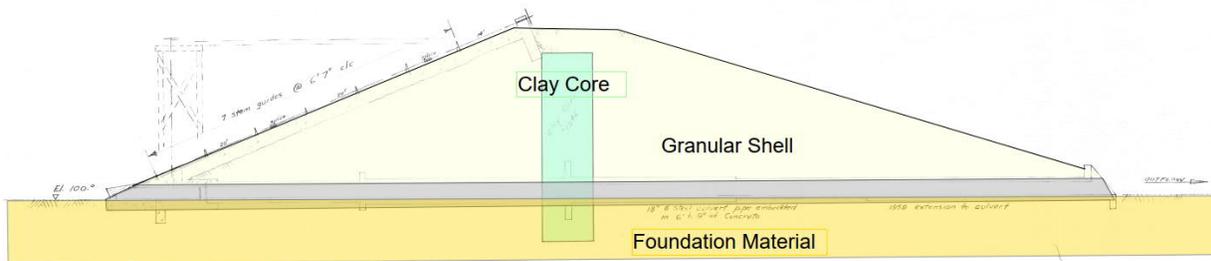
Figure 7-2: Typical Cross Section of the Elinor South Embankment Dam

The central core of the dam is constructed with clay core materials with vertical side slopes which is considered non-conventional which could be due to the lack of considerable quantity of clay materials at the site. The cores are generally constructed with inclined slopes so that no core/shell separation and sliding take place and the core materials experience vertical positive stress from the shell materials. As shown in Figure 7-2 the clay core is extended into foundation materials, however, little information exists on the foundation material, embedment core depth, or foundation excavation footprints.

Following inspection of the South Dam in 1991, which noted significant seepage along the toe of the embankment, the installation of a 1.0 m deep granular toe drain incorporating a 0.3 m diameter perforated pipe was recommended; however it is unknown if these works were undertaken (OMS, 2017).

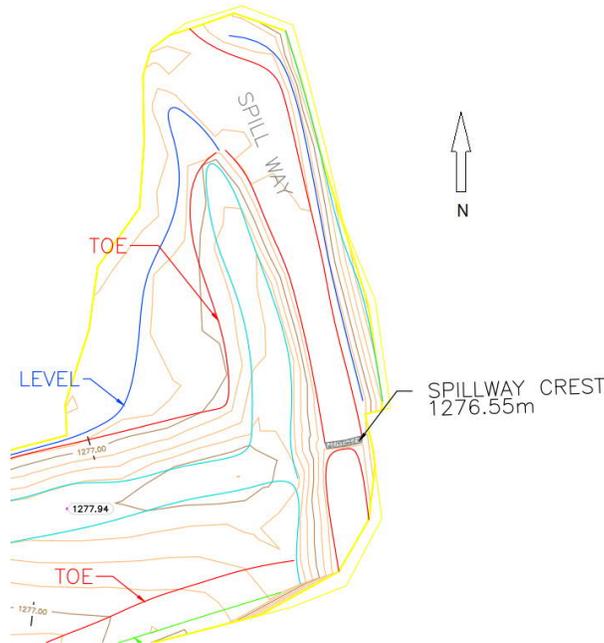
Figure 7-3: Spillway Plan at Elinor South Dam Site – (Okanagan Survey, 2012)

The spillway was constructed on the left abutment of the Elinor South Dam on the overburden material. The channel appears to be lined with masonry rock and on the sidewalls. The spillway sidewalls were found to be generally in good condition with no sign of distress (Okanagan Survey, 2012). The existing survey does not provide details of the side slopes inclination. Hatch recommends a detailed condition assessment of the spillway masonry rock.

Figure 7-3 illustrates the spillway site plan, channel, and sill as surveyed by Okanagan Survey (2012) located on the left abutment of the Elinor South Dam. A safety boom exists upstream of the spillway channel which drains to the Naramata Reservoir downstream. Hatch does not anticipate flow induced erosion in this channel. The slopes on the sides of the channel were found stable and consistent with earthen channels. No drawing exists providing details of the channel slopes and materials.

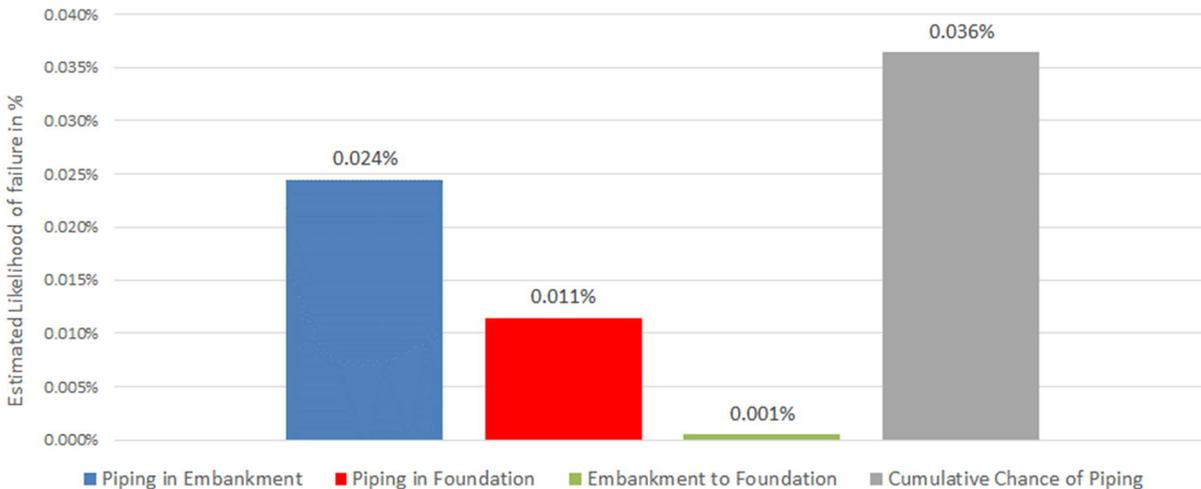
Figure 7-10: Estimated Annual Probability of Failure of the Elinor Lake South Dam Using Foster and Fell [2000]

In its existing condition, the total probability of piping failure at the Elinor Lake South Earthfill Dam appears to be close to unacceptable ranges. However, this potential can be reduced in a number of ways. First, as can be observed in Figure 7-11, the broadly acceptable band is highly influenced by the potential number of people.

- Provide additional training and instruction to Dam Operators to property identify, sample and respond to seepage turbidity would reduce the piping risk. Seasonal turbidity laboratory tests could then be conducted on any water samples taken (see Issue No.ES-3, All-7 in Table 13-1)

- Structural mitigation in terms of installing piping control measures such as a reverse filter blanket at the toe of dam is an alternative measure which might be considered for the Elinor South Dam which may be recommended following a geotechnical investigation and assessment. (see Issues ES-2C, ES-5, and ES-6 in Table 13-1).
- Install tick filter zone around the Outlet Conduit as per recommendation by USBR (1989).
- Conduct geotechnical investigation and assessments to further assess the internal zoning, internal stability, and filter criteria.
- Install additional instrument at dams to measure internal pore water pressure and total seepage quantity, by the installation of piezometers and weir(s), respectively.

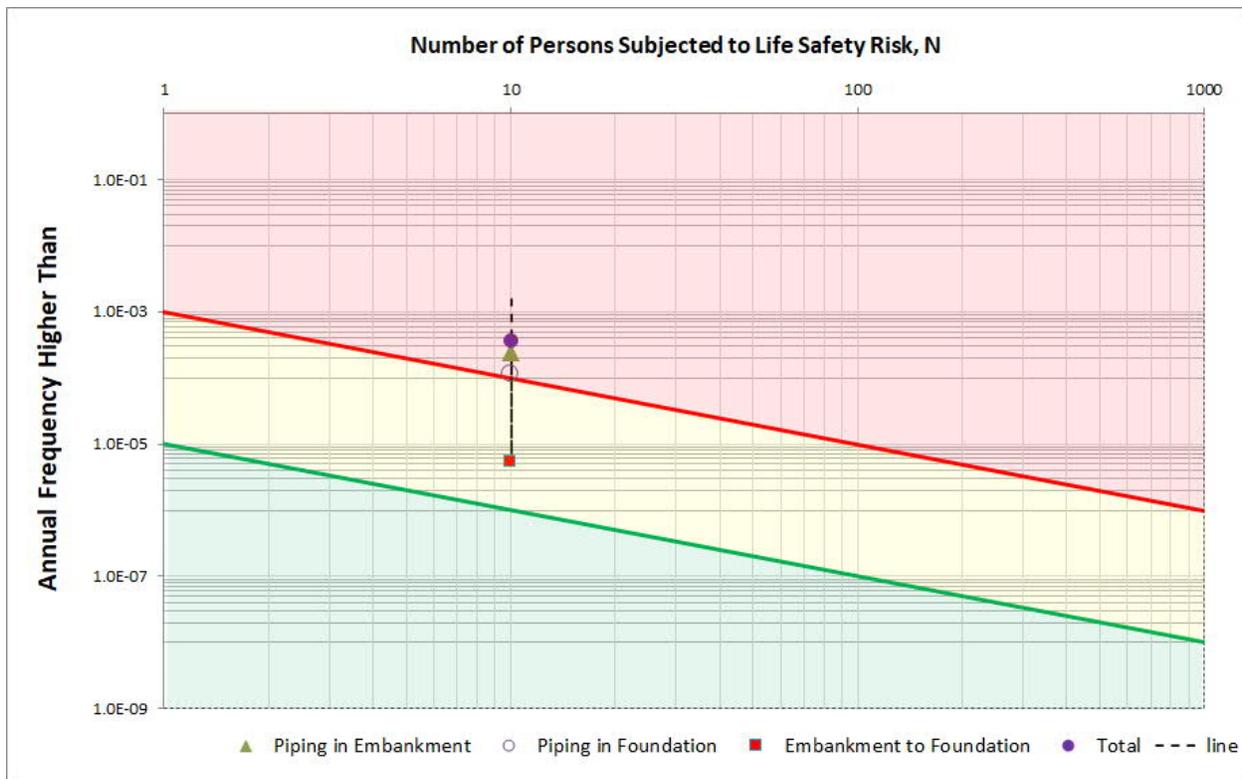
Figure 7-11: Existing Risk Acceptability for Elinor South Earthfill Dam Considering DFCC of 10

According to CDA Guidelines [CDA, 2013a], life safety risk should be consistent with values used in other hazardous industries and with the principle that risks should be made as low as reasonably practicable (ALARP). Using this principal, a better understanding of the piping risks can be obtained by plotting annual exceedance probability against the expected number of persons subjected to a Life Safety Risk. Figure 7-11 outlines the piping risk with regards to life safety risk using the DFCC of “High” an assuming a potential for Loss of Life.

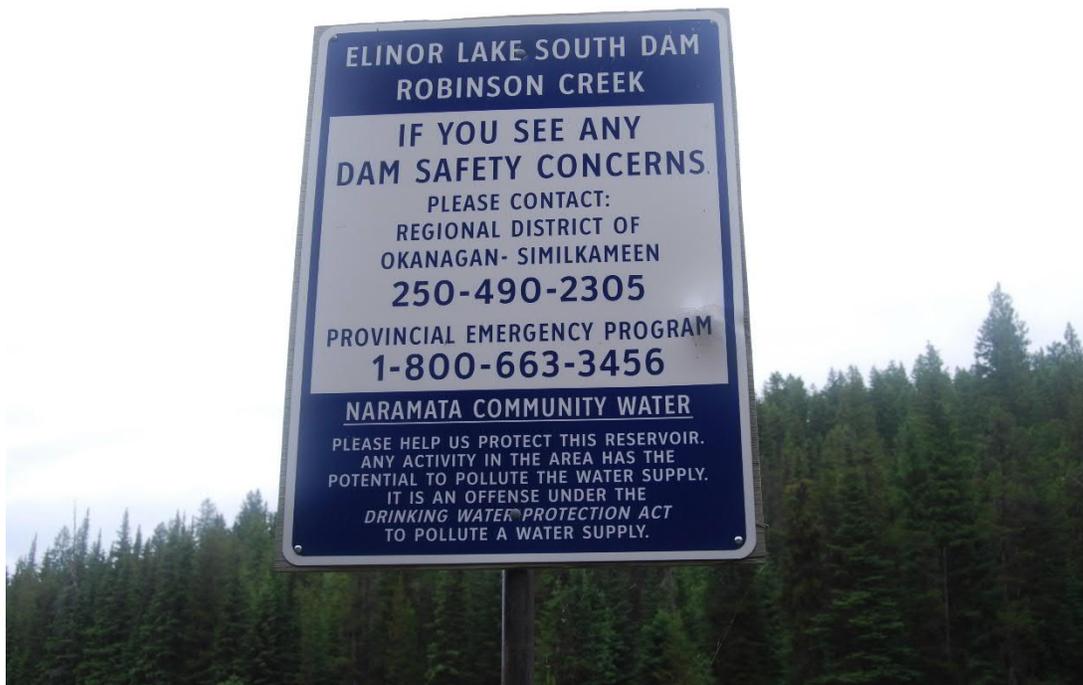
Photo A10: Elinor Lake South Dam, Public Safety Sign

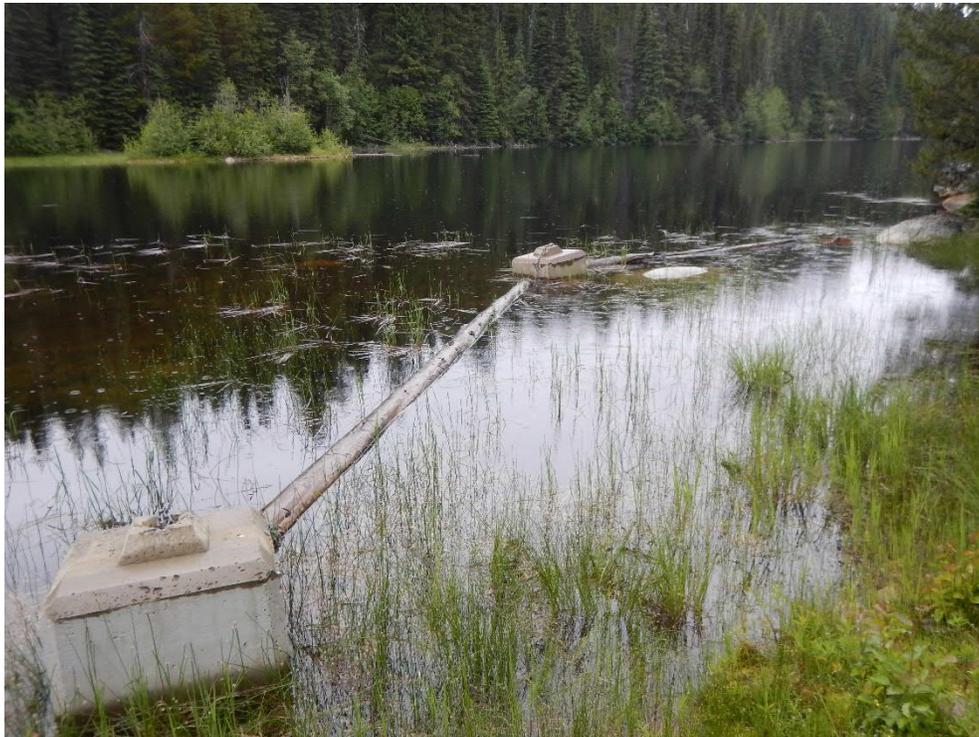
Photo A14: Elinor Lake South Dam, Log Boom

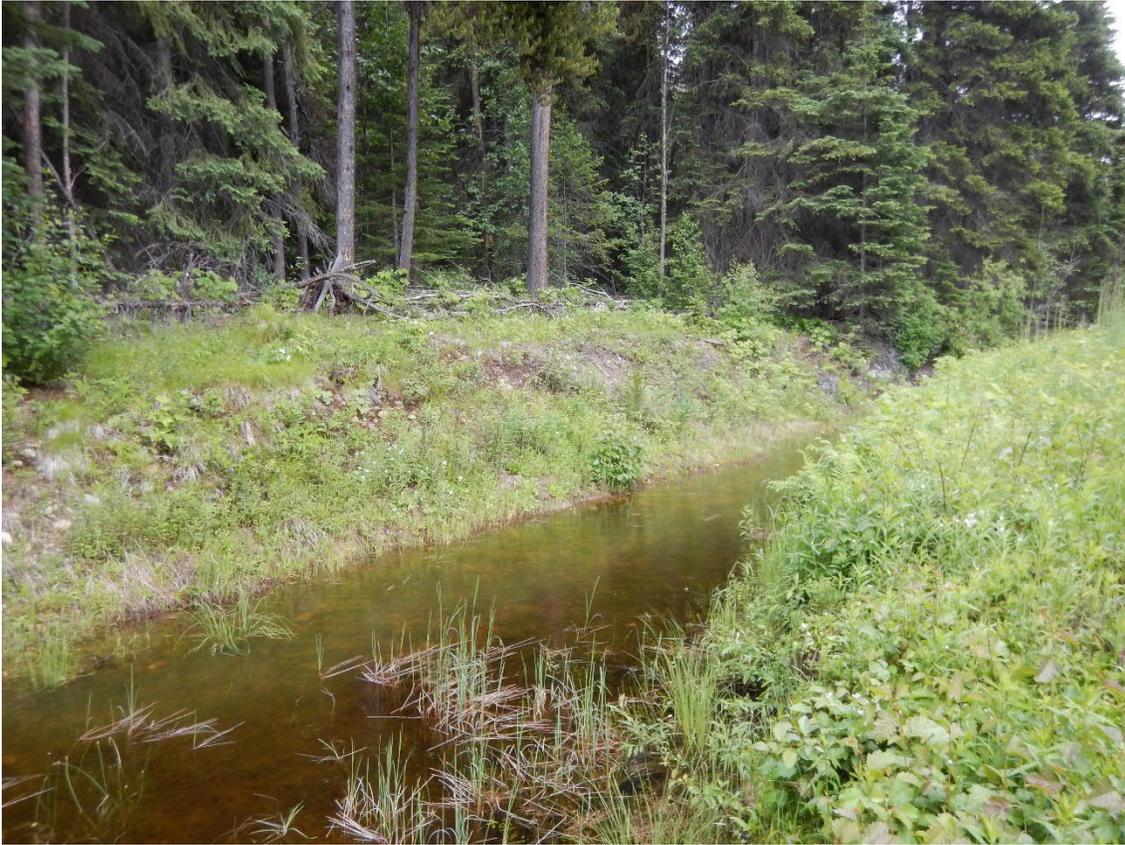
Photo A15: Elinor Lake South Dam, Spillway Channel and Areas on Left Abutment

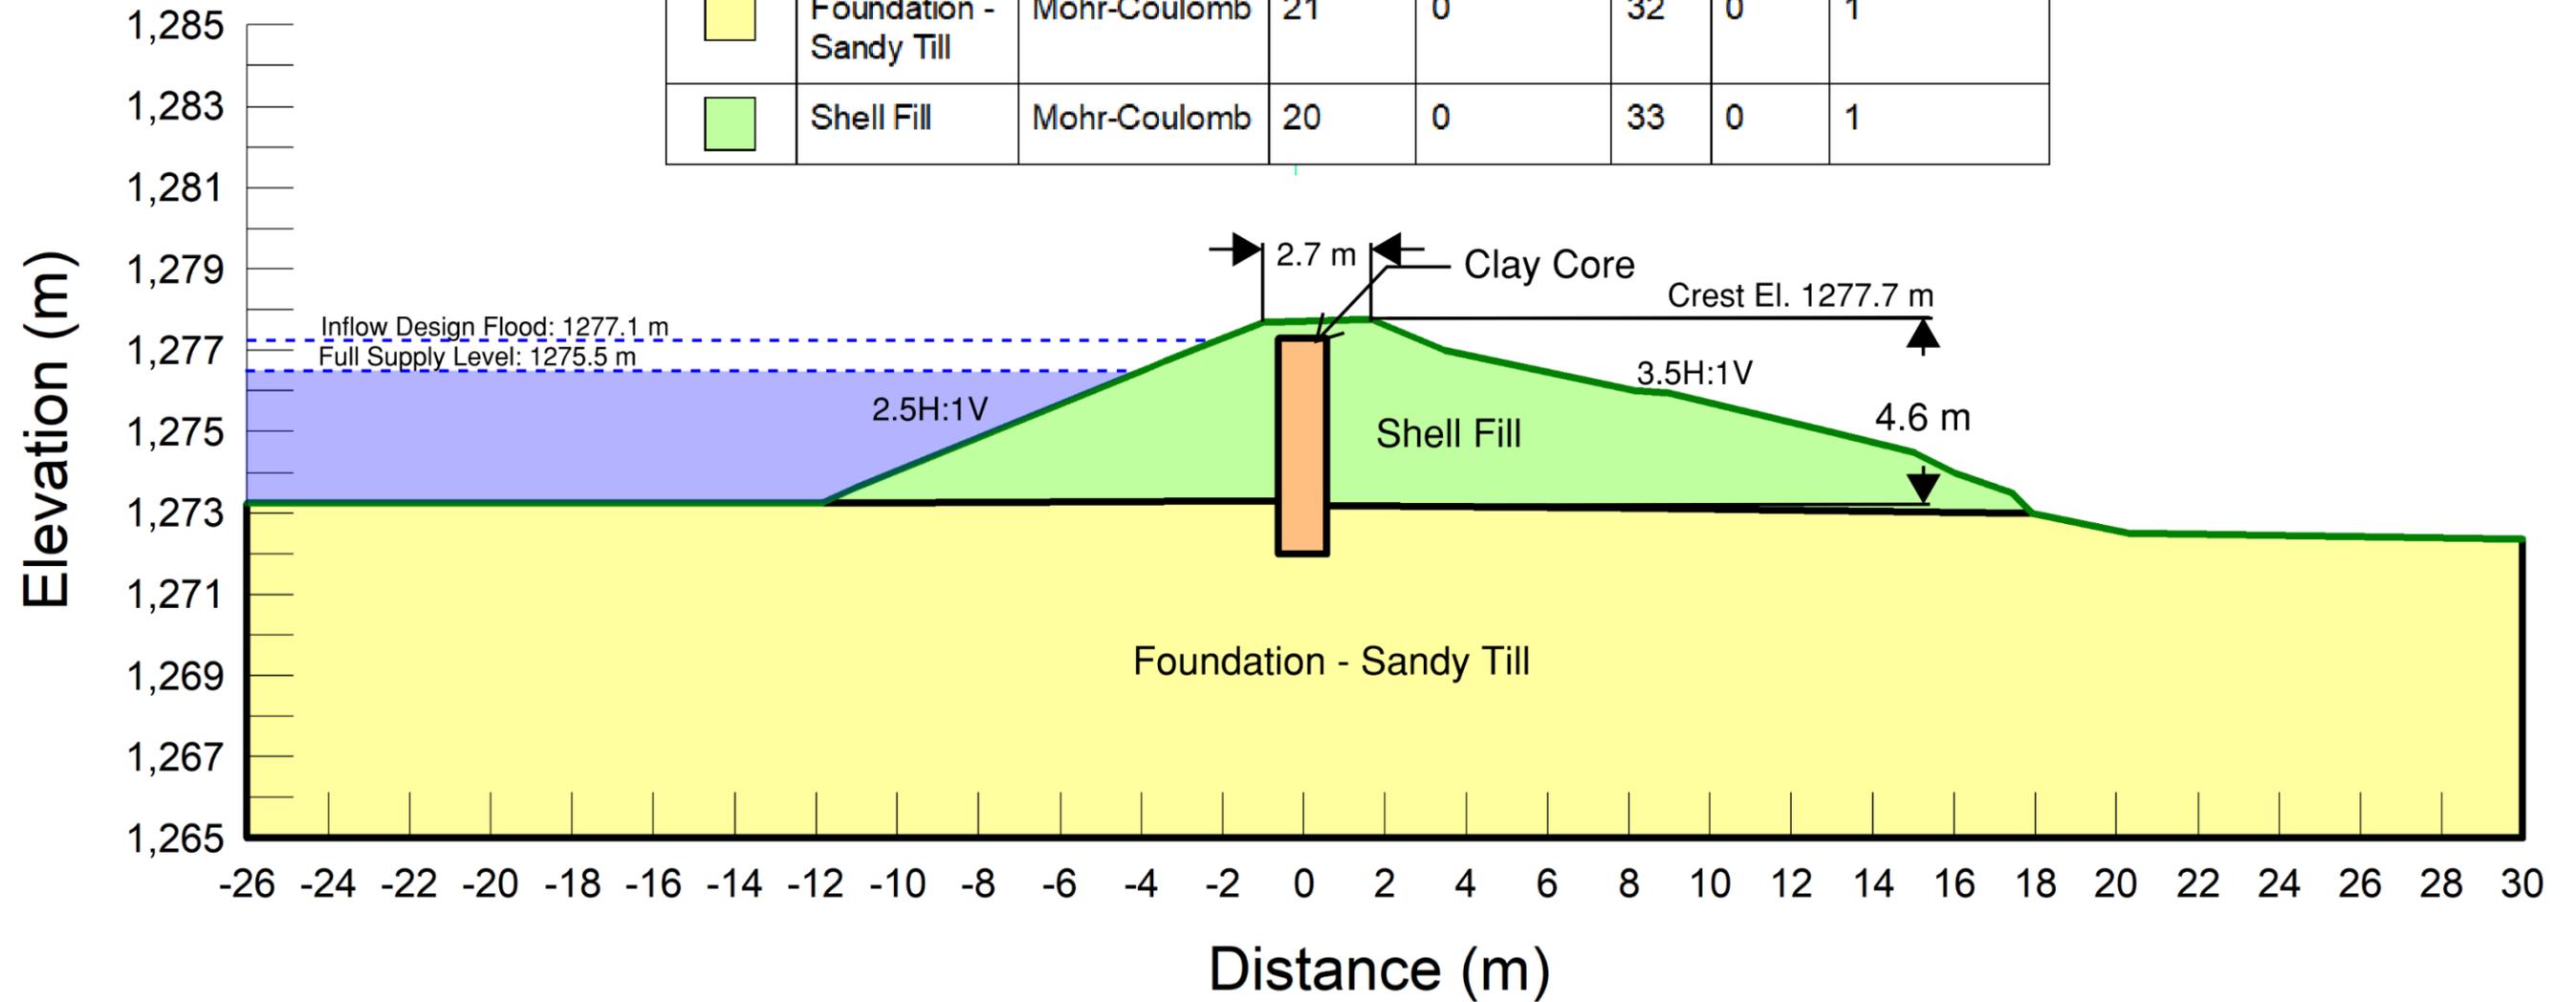
Project		Elinor Lake South Dam – Dam Safety Review	
Analysis Description		Slope Stability Analysis – Model Geometry	
Analysis By	T. Tuo	Output	Model Geometry
Date	11/01/2021	Report No.	H362819

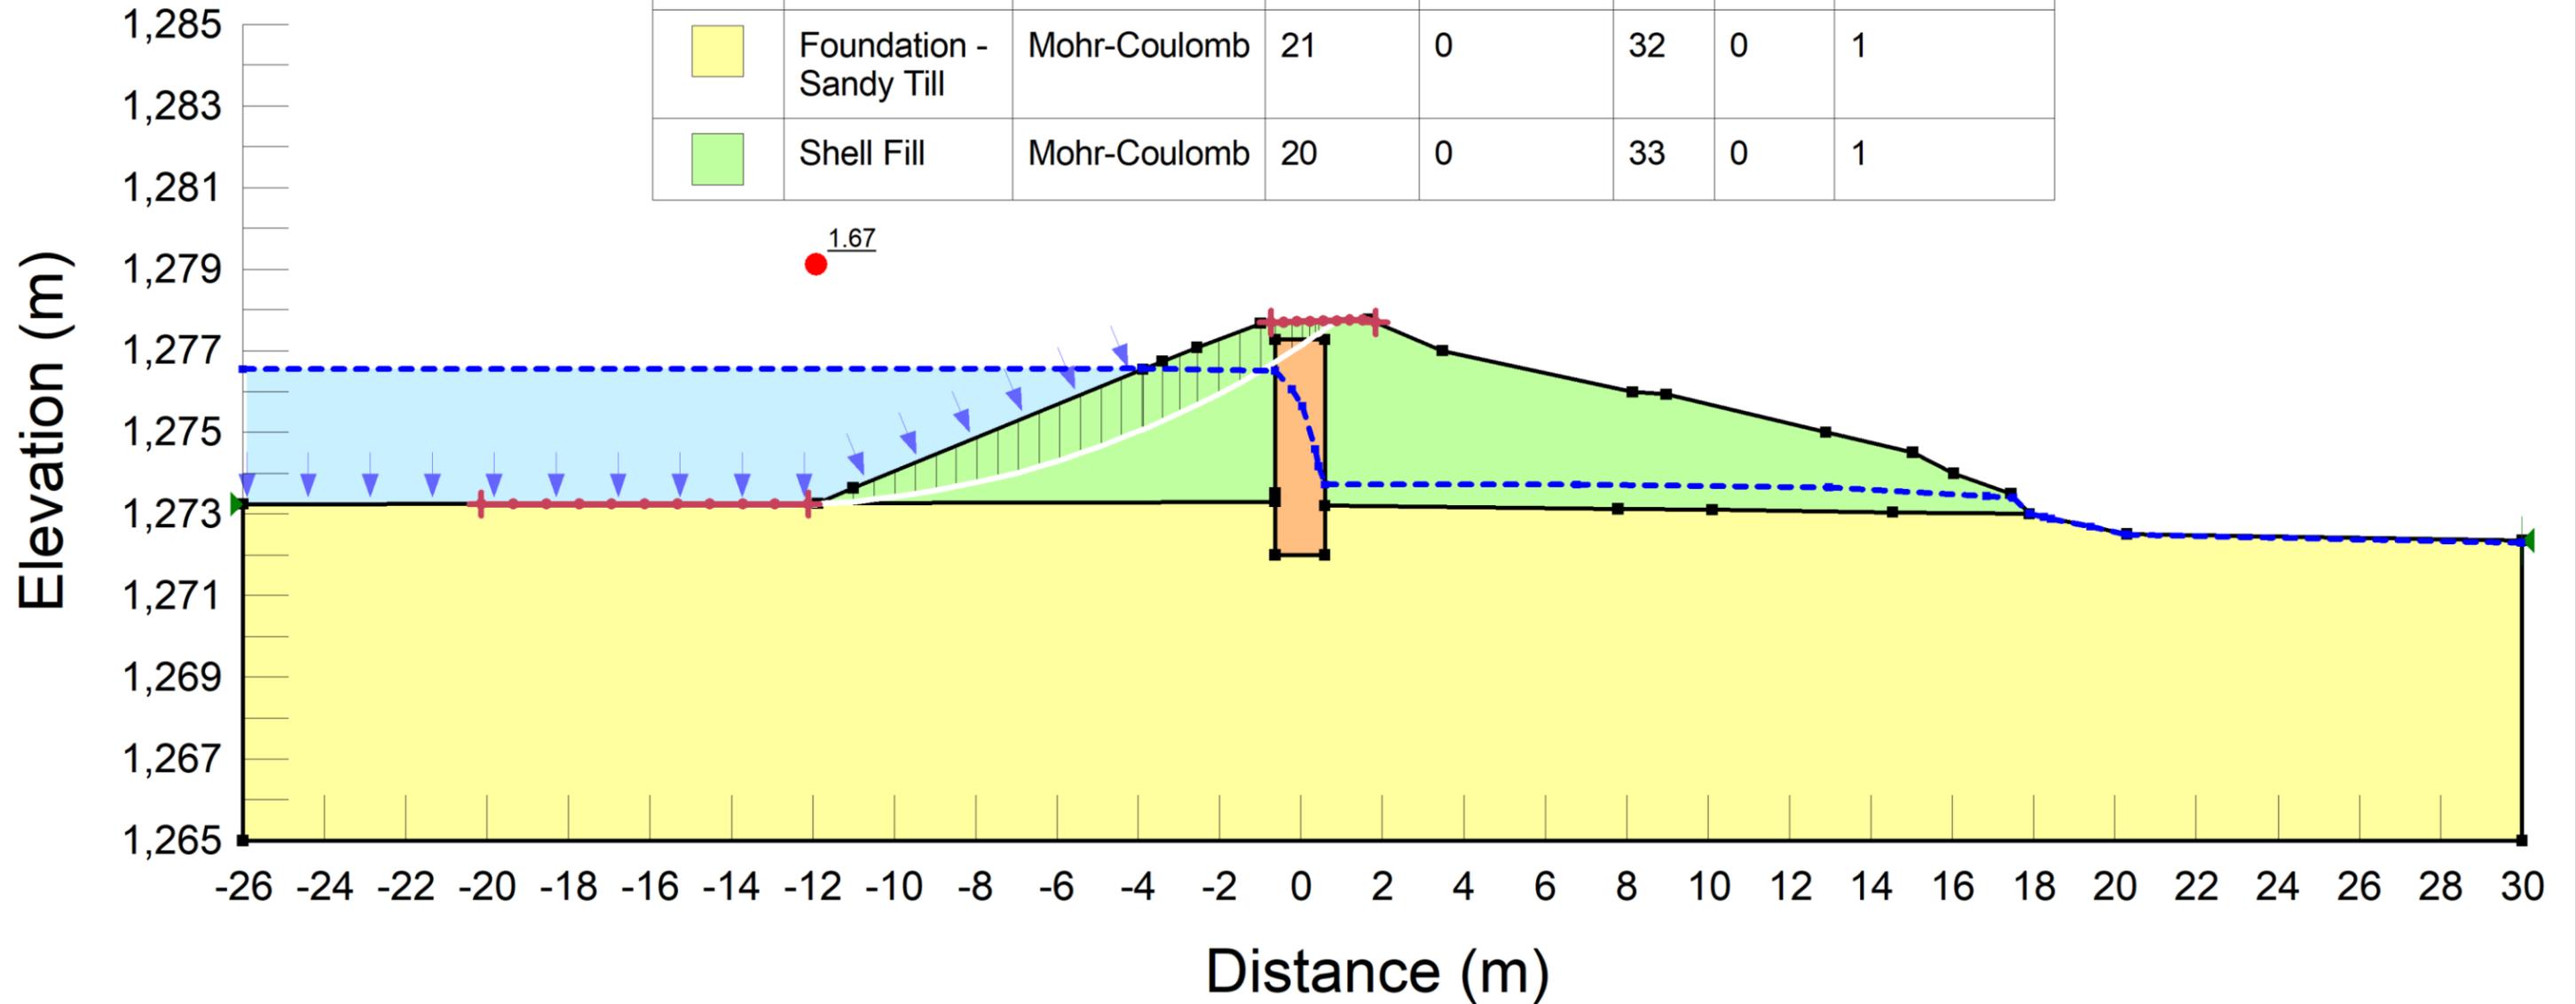
Project		Elinor Lake South Dam – Dam Safety Review	
Analysis Description		Slope Stability Analysis: LC-1 – Normal Load Condition – Full Supply Level	
Analysis By	T. Tuo	Slope	Upstream
Date	11/01/2021	Report No.	H362819

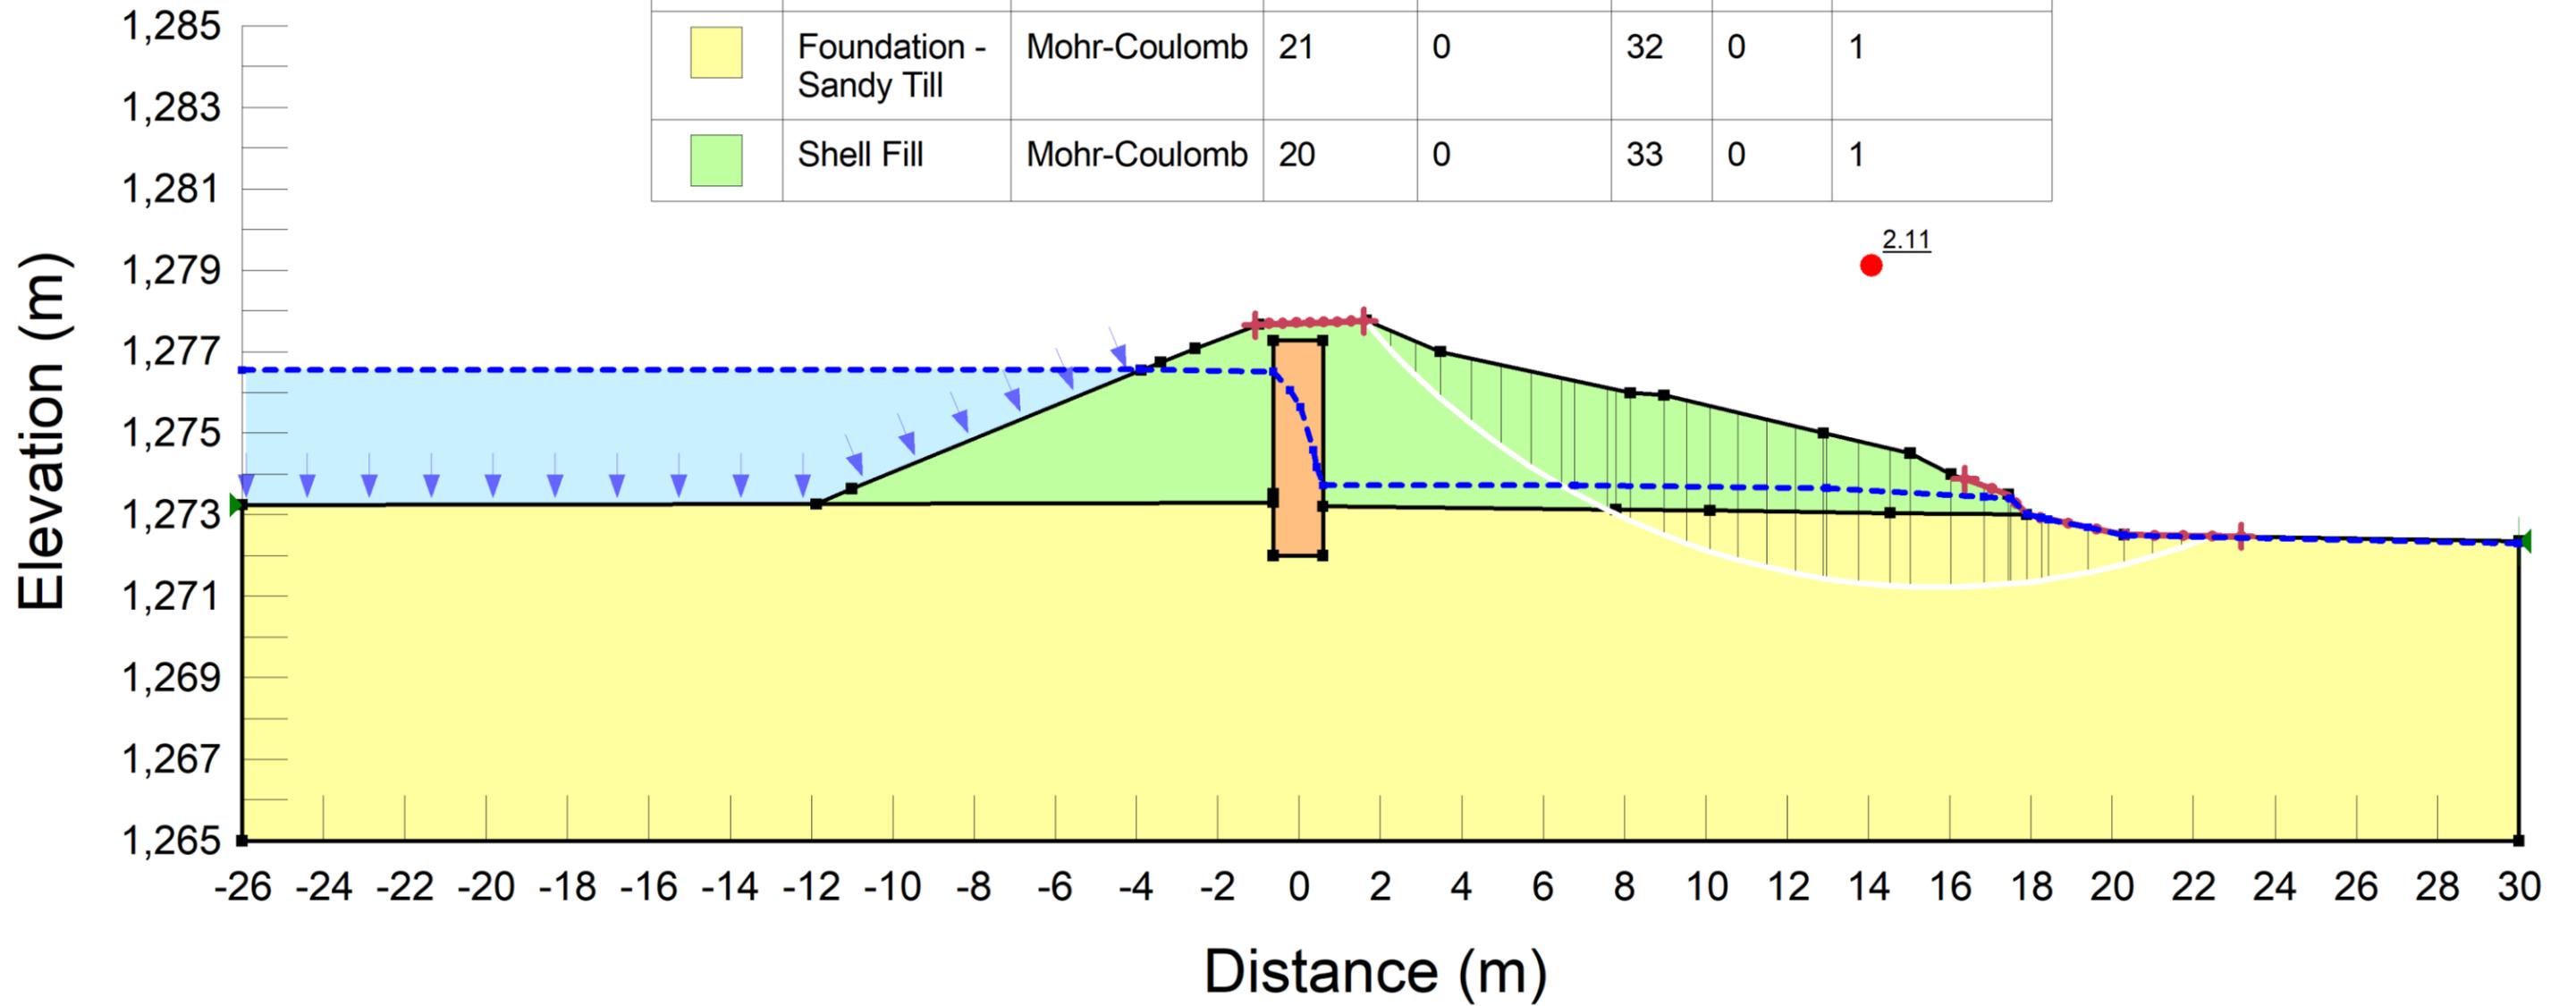
Project		Elinor Lake South Dam – Dam Safety Review	
Analysis Description		Slope Stability Analysis: LC-1 – Normal Load Condition – Full Supply Level	
Analysis By	T. Tuo	Slope	Downstream
Date	11/01/2021	Report No.	H362819

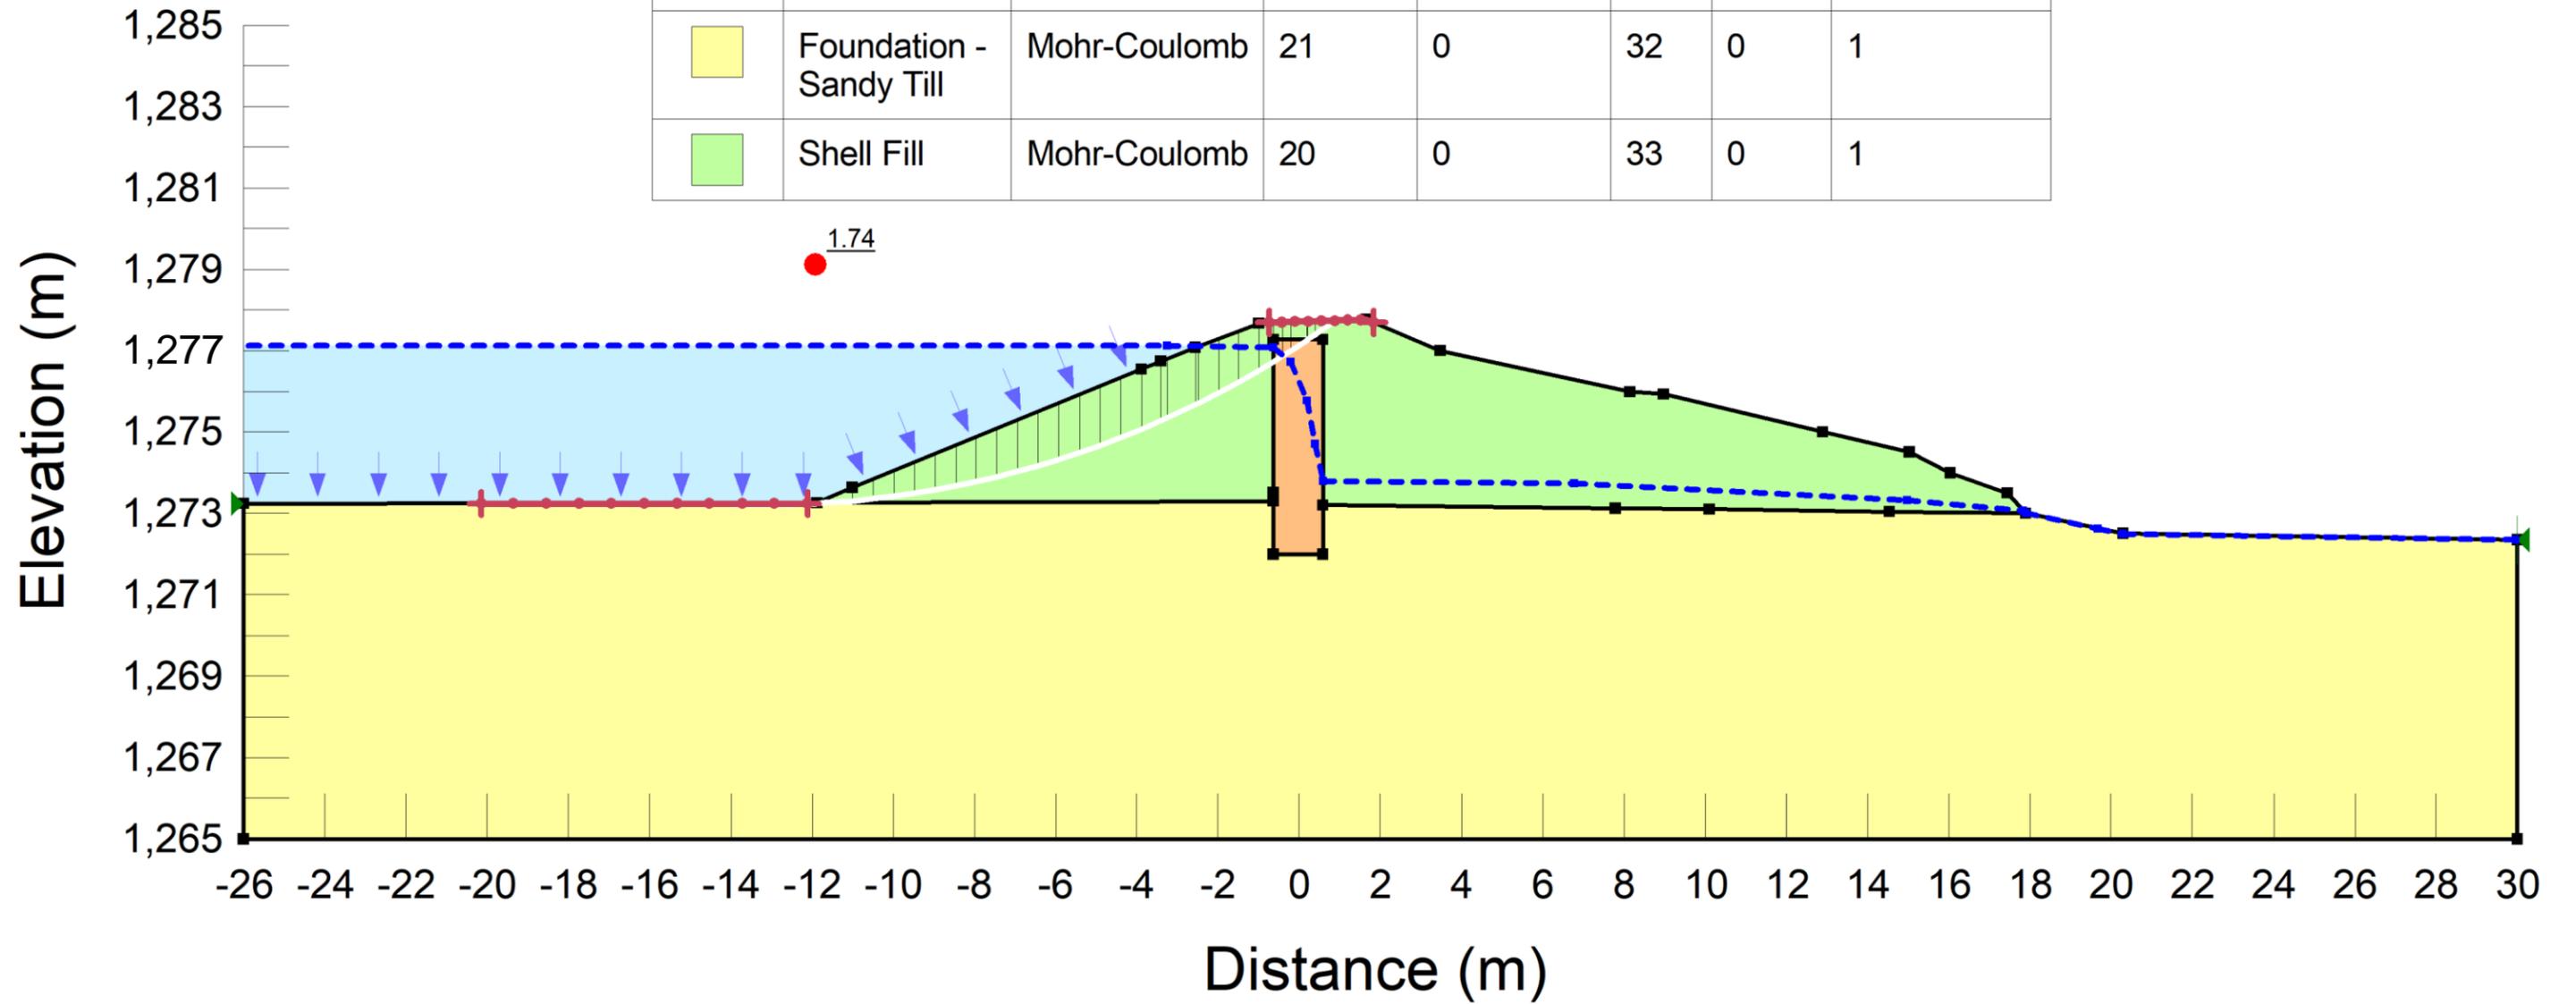
Project		Elinor Lake South Dam – Dam Safety Review	
Analysis Description		Slope Stability Analysis: LC-2 – Flood Load Condition – Inflow Design Flood	
Analysis By	T. Tuo	Slope	Upstream
Date	11/01/2021	Report No.	H362819

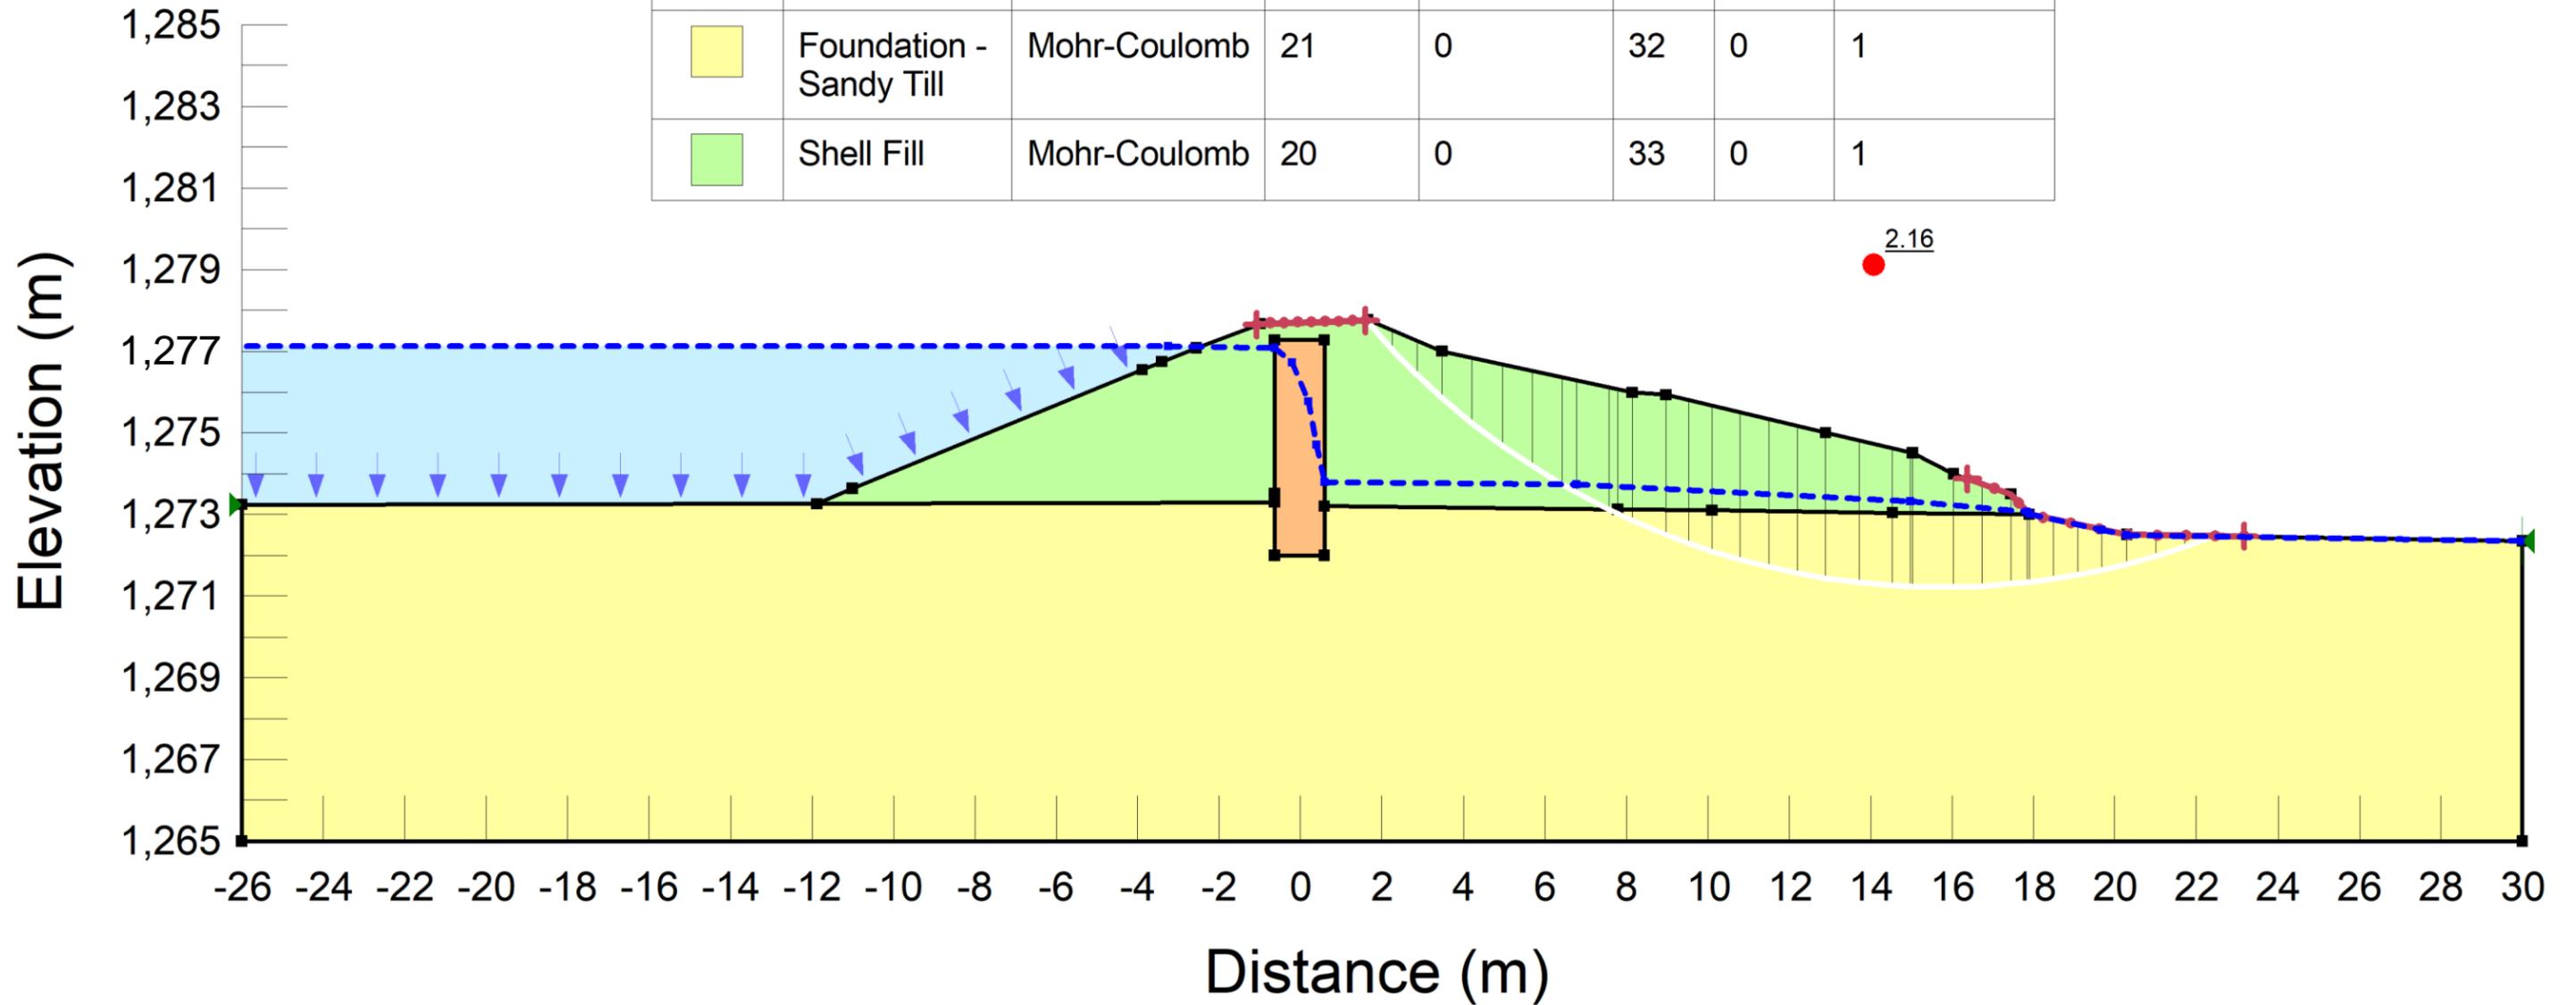
Project		Elinor Lake South Dam – Dam Safety Review	
Analysis Description		Slope Stability Analysis: LC-2 – Flood Load Condition – Inflow Design Flood	
Analysis By	T. Tuo	Slope	Downstream
Date	11/01/2021	Report No.	H362819

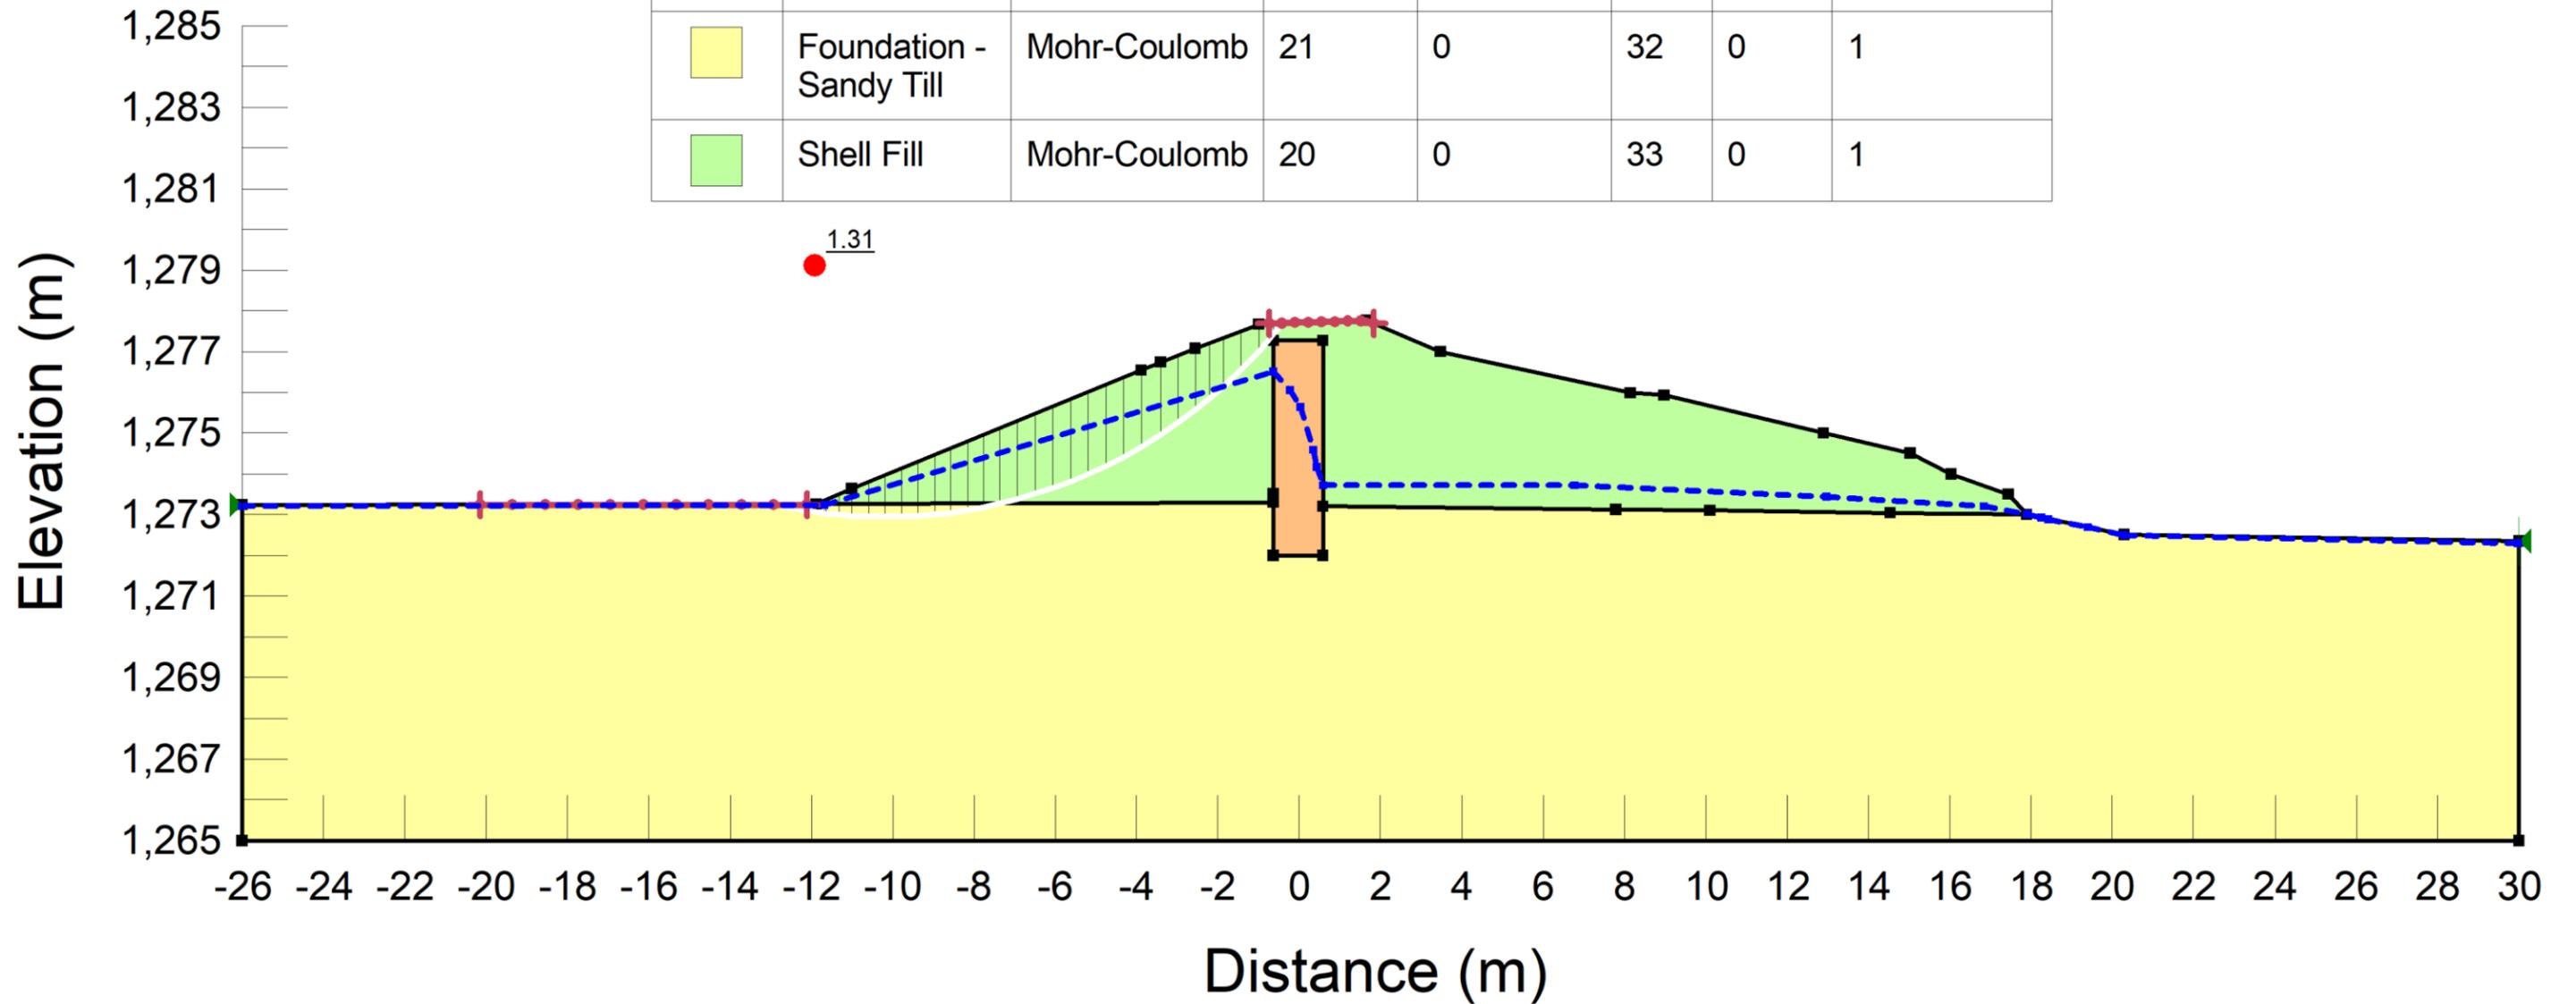
Project		Elinor Lake South Dam – Dam Safety Review	
Analysis Description		Slope Stability Analysis: LC-3 – Rapid Draw Down – From Full Supply Level	
Analysis By	T Singh	Slope	Upstream
Date	11/01/2021	Report No.	H362819
