Elinor Lake South Dam 2020 Dam Safety Review Report

For Regional District of Okanagan-Similkameen

Elinor Lake South Dam - 2020 Dam Safety Review Report

H362819-00000-228-230-0004

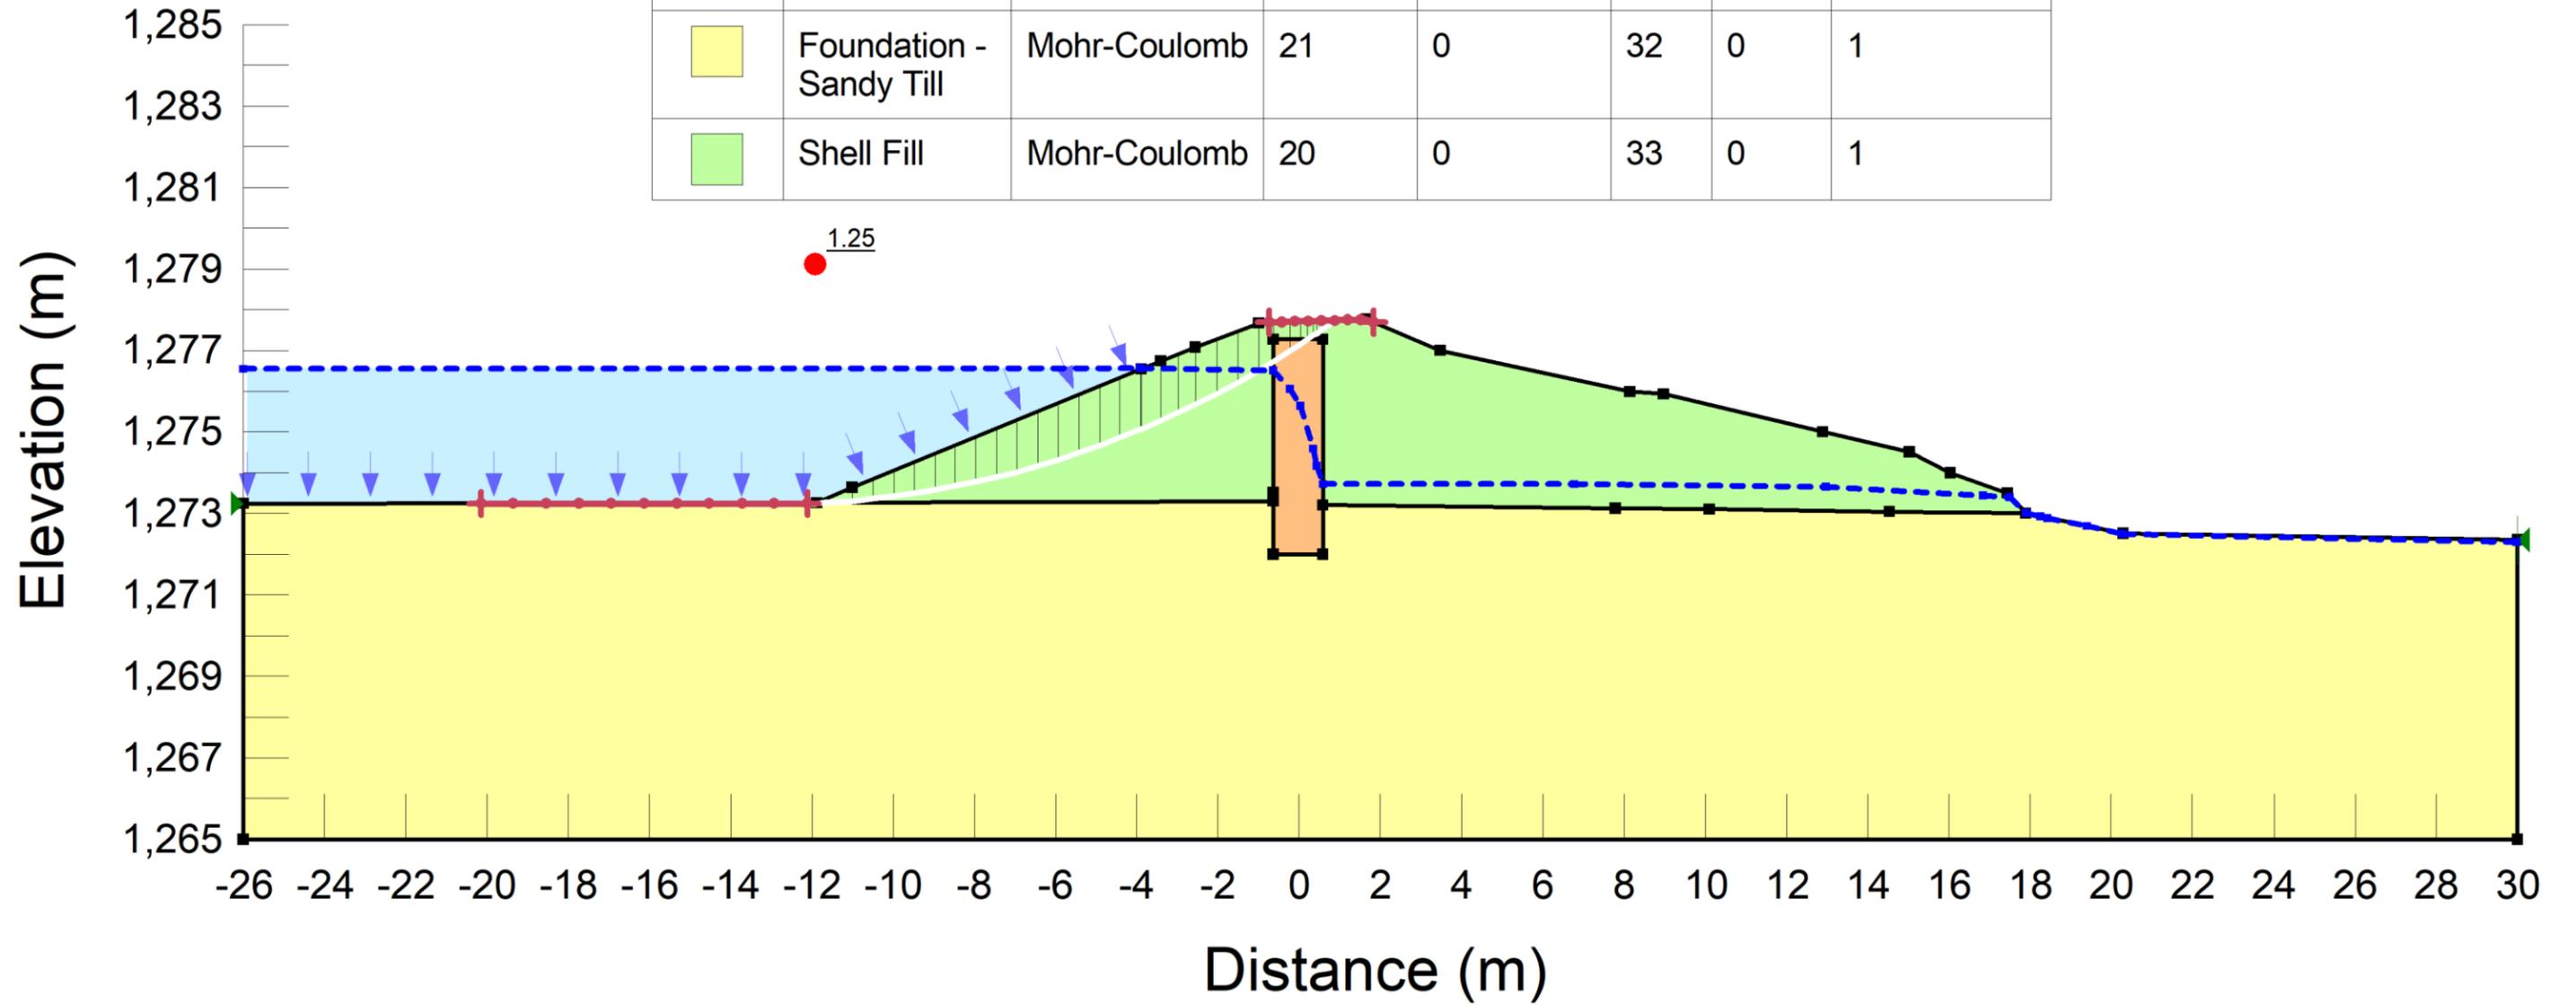
Project		Elinor Lake South Dam – Dam Safety Review	
Analysis Description		Slope Stability Analysis: LC-4 – Seismic Condition – Full Supply Level	
Analysis By	T Singh	Slope	Upstream
Date	11/01/2021	Report No.	H362819

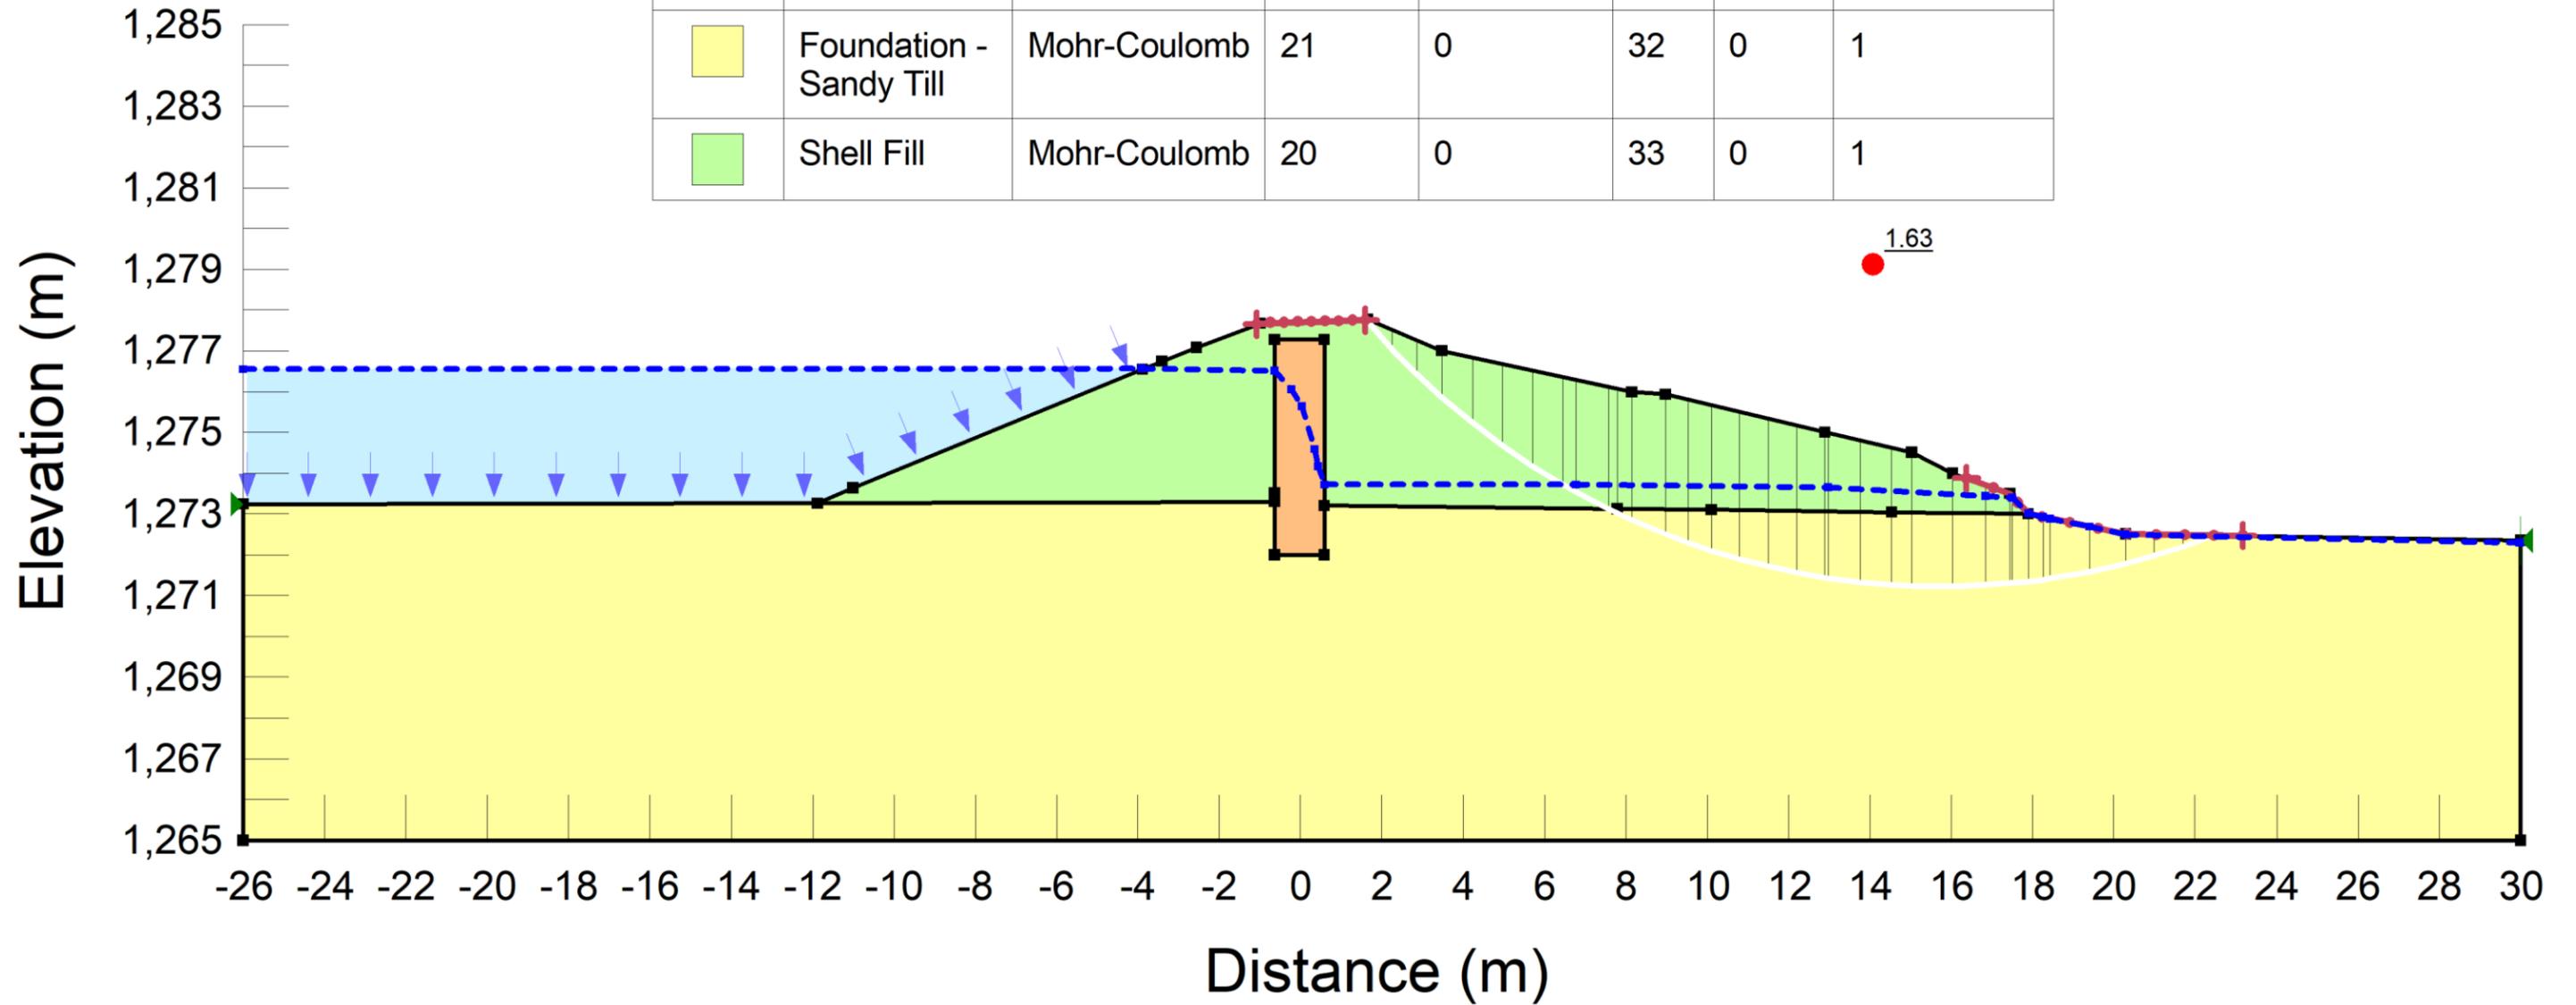
Project		Elinor Lake South Dam – Dam Safety Review	
Analysis Description		Slope Stability Analysis: LC-4 – Seismic Condition – Full Supply Level	
Analysis By	T. Tuo	Slope	Downstream
Date	11/01/2021	Report No.	H362819
